CLUB DE GOLF LOS LEONES LAS CONDES - SANTIAGO - CHILE

SITE REPORT FOLLOWING VISIT IN JANUARY 2011

A D A M G O L F D E S I G N ARQUITECTOS DE CANCHAS DE GOLF

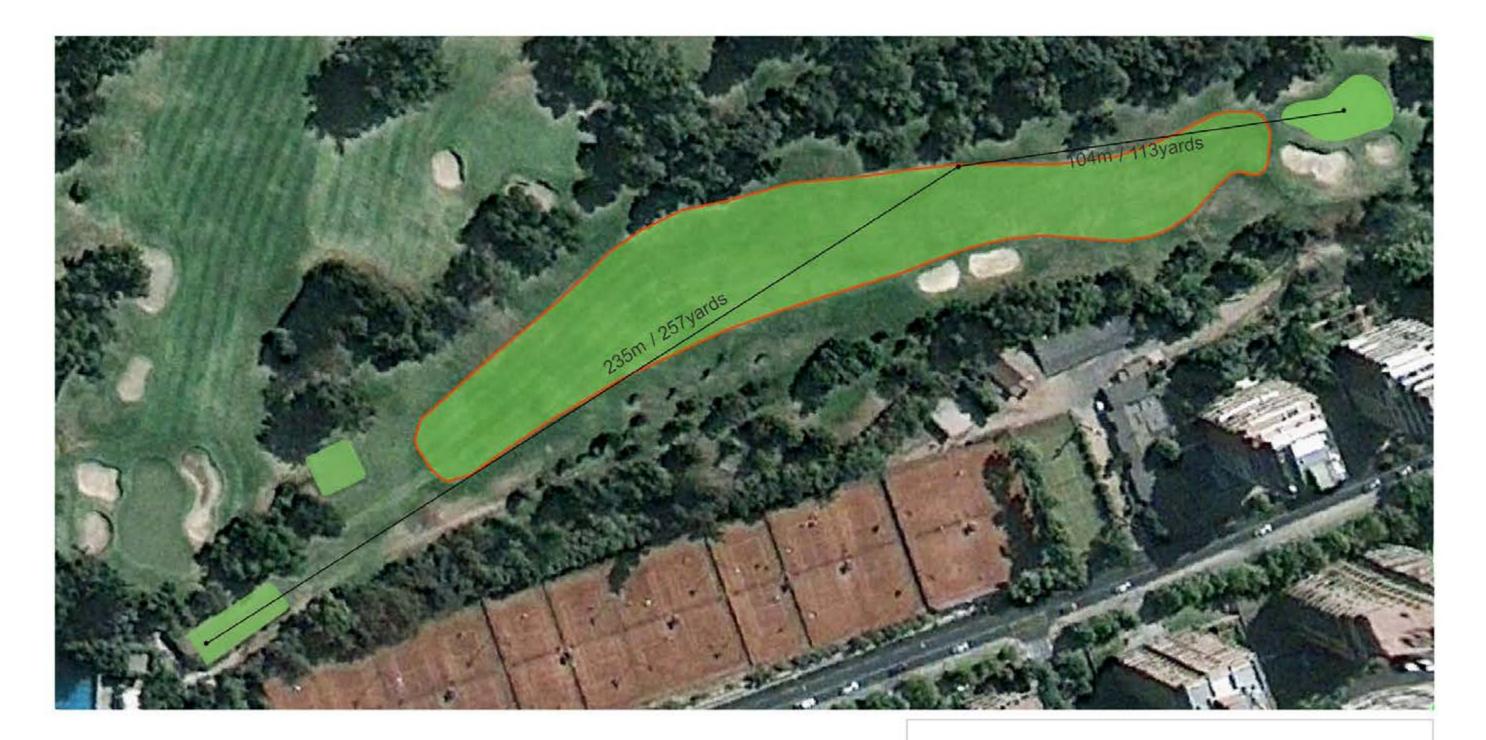
EXISTING ROUTING - HOLE N°1

At present the two fairway bunkers on the right side of the landing are invisible from the tee. The bunkers will be even more invisible in the future due to the recently planted tree on the right in the rough. There is also an area on the left side of the fairway 70 metres after the tee, that no longer needs to be maintained as fairway. There is also a safety issue, with errant balls off the tee landing in the tennis courts and the maintenance building.

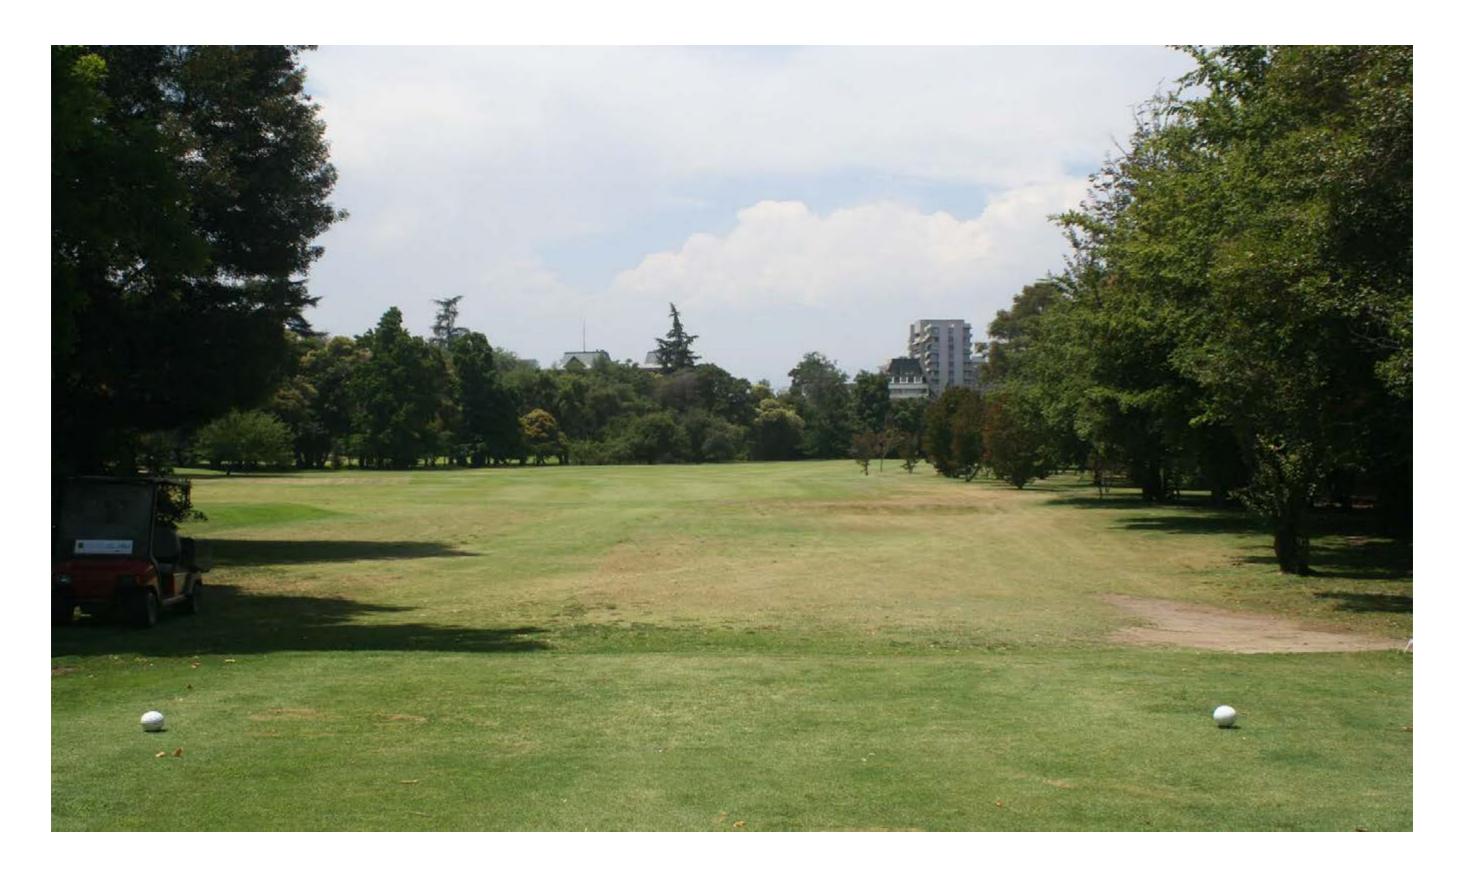
EXISTING VIEW FROM THE TEE - HOLE N°1

At present the two fairway bunkers on the right side of the landing are invisible from the tee. The bunkers will be even more invisible in the future due to the recently planted trees on the right in the rough. There is also an area on the left side of the fairway 70 metres after the tee, that no longer needs to be maintained as fairway. There is also a safety issue, with errant balls off the tee landing in the tennis courts and the maintenance building.

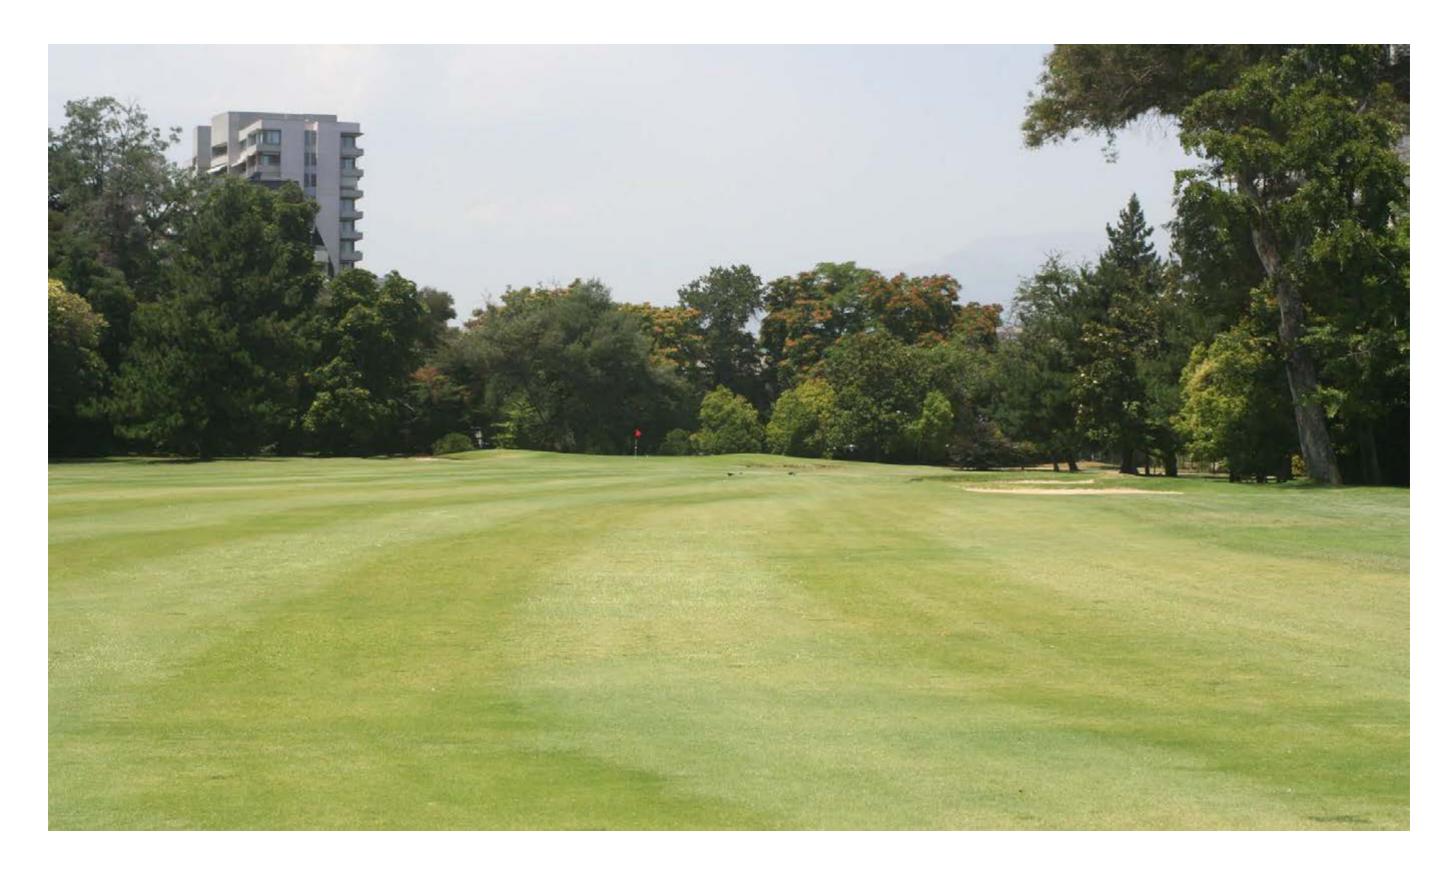
EXISTING VIEW FROM THE LANDING AREA TOWARDS THE GREEN - HOLE N°1

At present the left green bunker is barely visible and the lip is difficult to maintain. The 1st green bunker on the right is hardly visible and the lip is difficult to maintain. The 2nd green bunker on the right is completely blind.

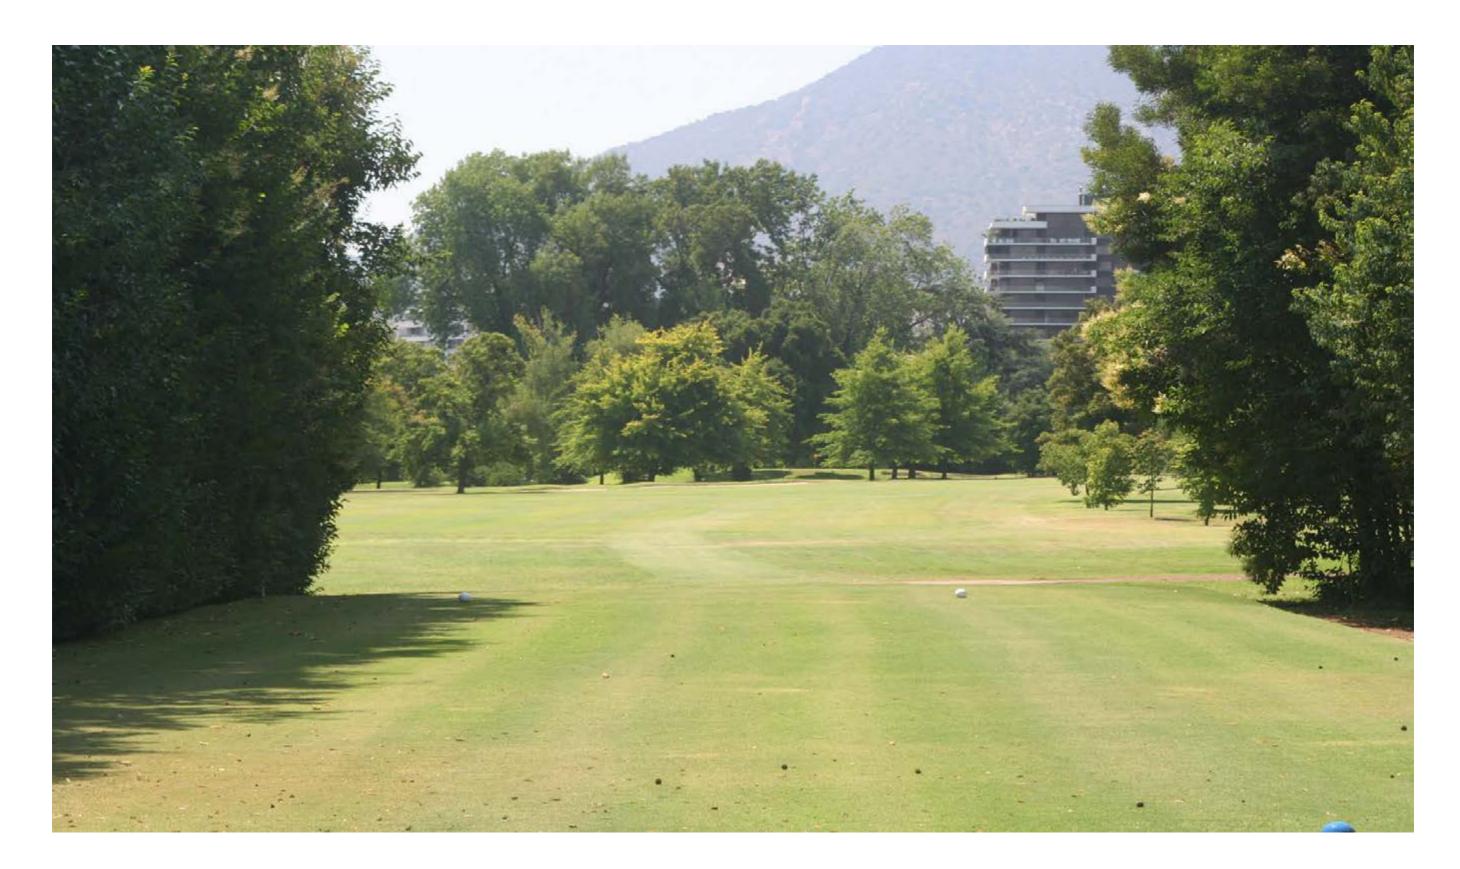
EXISTING VIEW FROM THE BACK TEE - HOLE N°2

At present the fairway bunkers on the left side of the fairway are barely visible. Some players are slicing the ball over the corner of the dog-leg to get extra length.

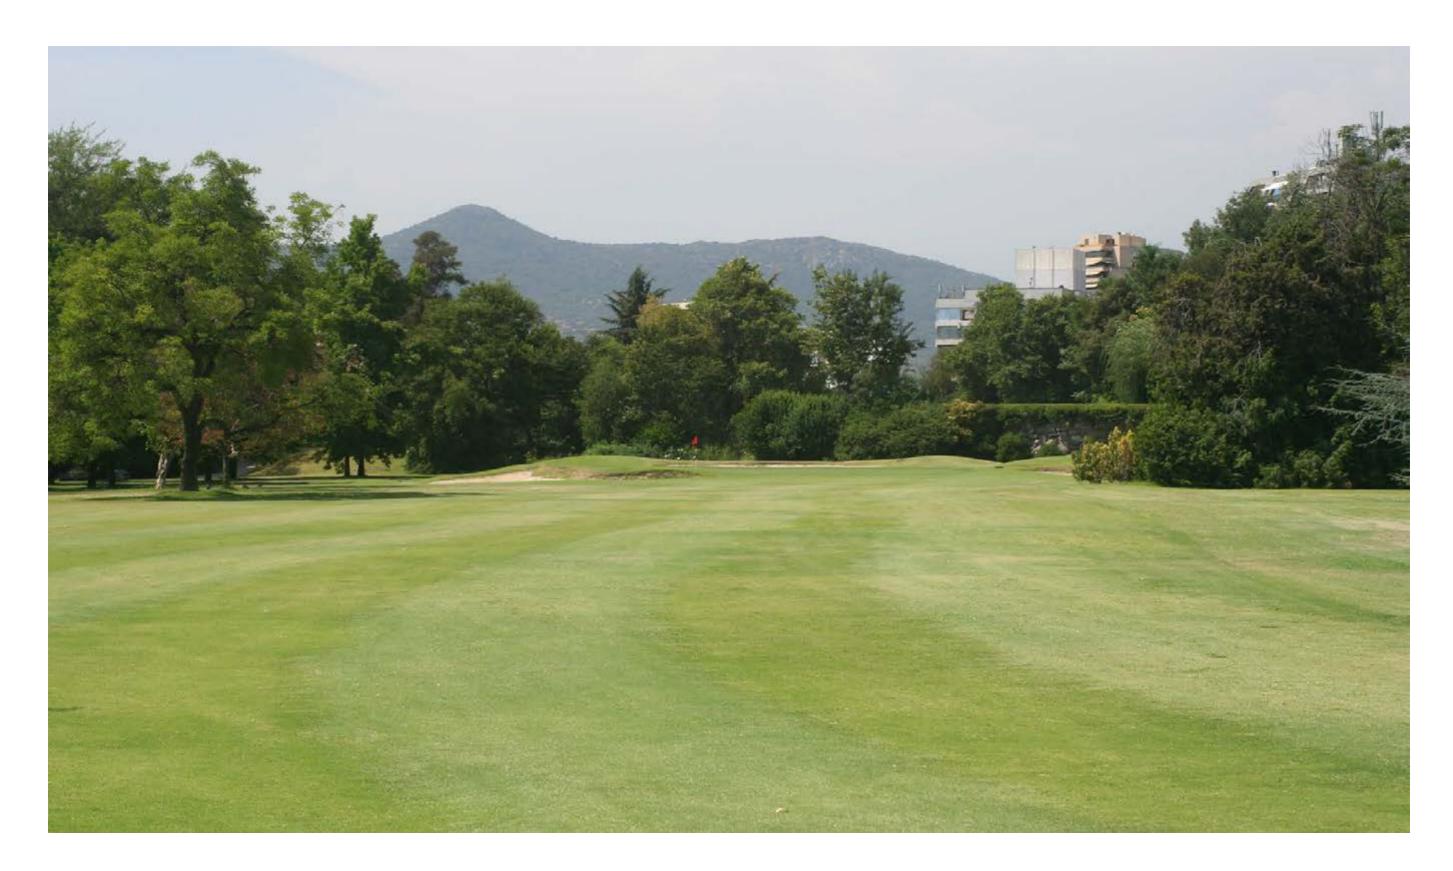
EXISTING VIEW FROM THE LANDING AREA - HOLE N°2

At present from the landing area the back green bunker is barely visible and the lip appears as a horizontal flat line. The front wall of the green bunker on the left side needs to be softened to facilitate maintenance and to create a better visual appearance. The view of the right green bunker from the landing area is partially blocked by the planted vegetation at the base of the tree. (Yellowish bush). The right side green bunker also needs to be made more visible.

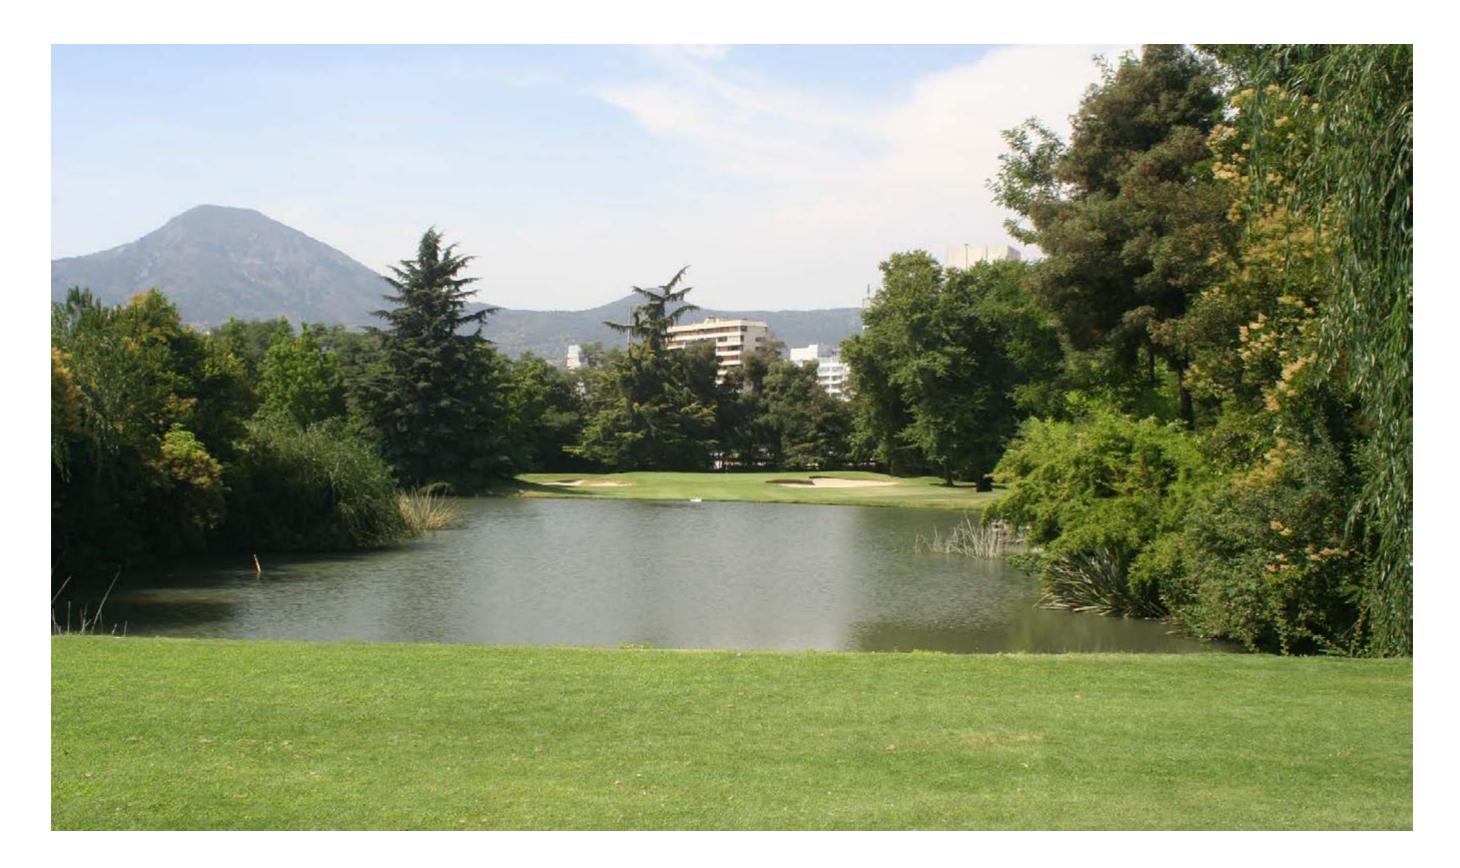
EXISTING VIEW FROM THE TEE - HOLE N°3

At present from the tee one can see the car traffic at the round about. The bunker edge of the left green bunker needs to be softened for visual and maintenance purposes.

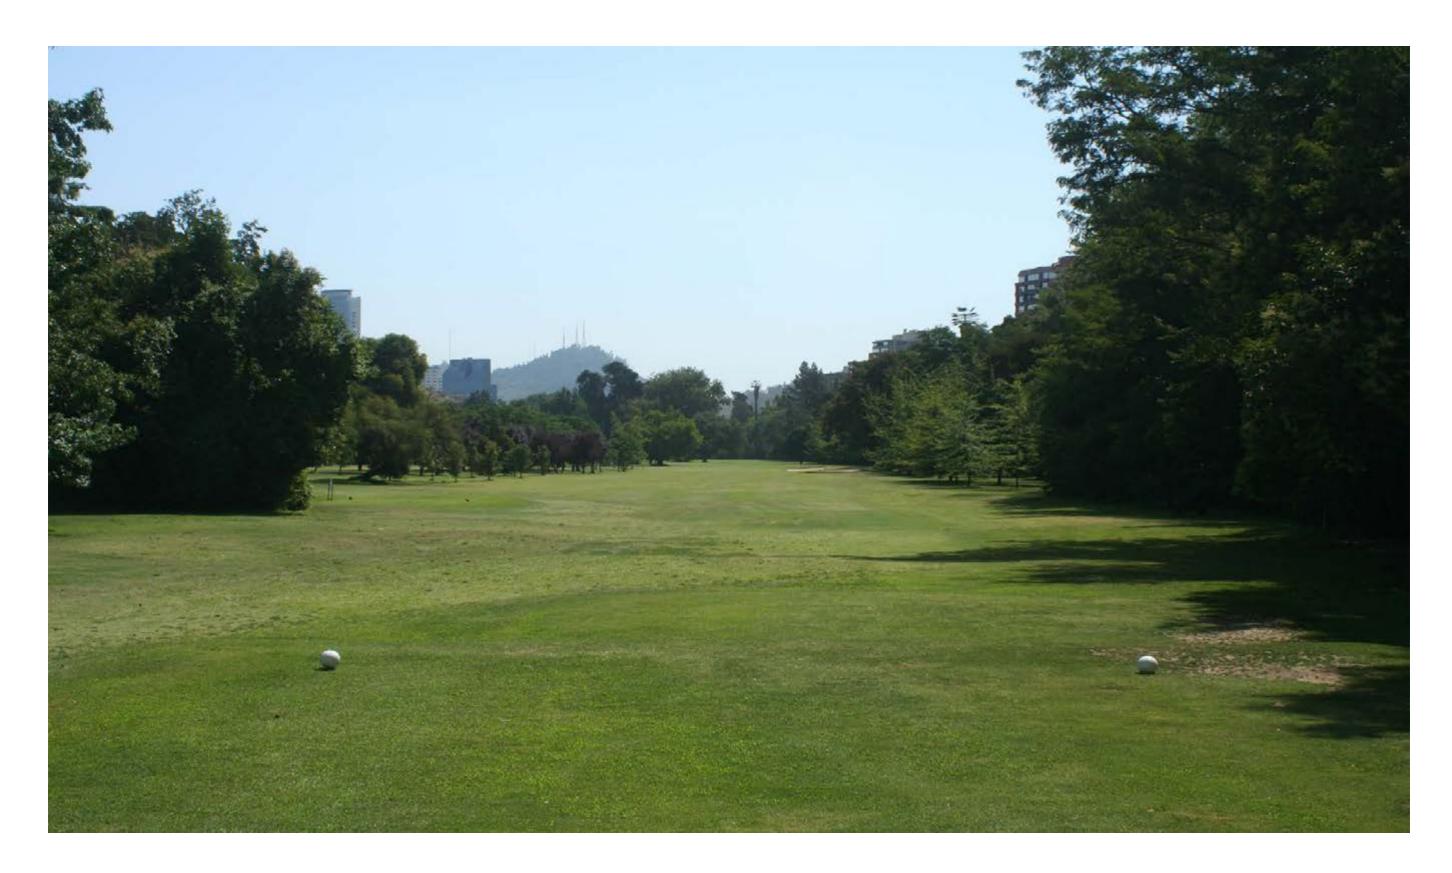
EXISTING VIEW FROM THE TEE - HOLE N°4

At present the two fairway bunkers are not penal enough and therefore lose in their strategic value. The vegetation needs to be reinforced along the road at the second landing area to improve safety. We should also look at the possibility of making the green bunker of the right more visible.

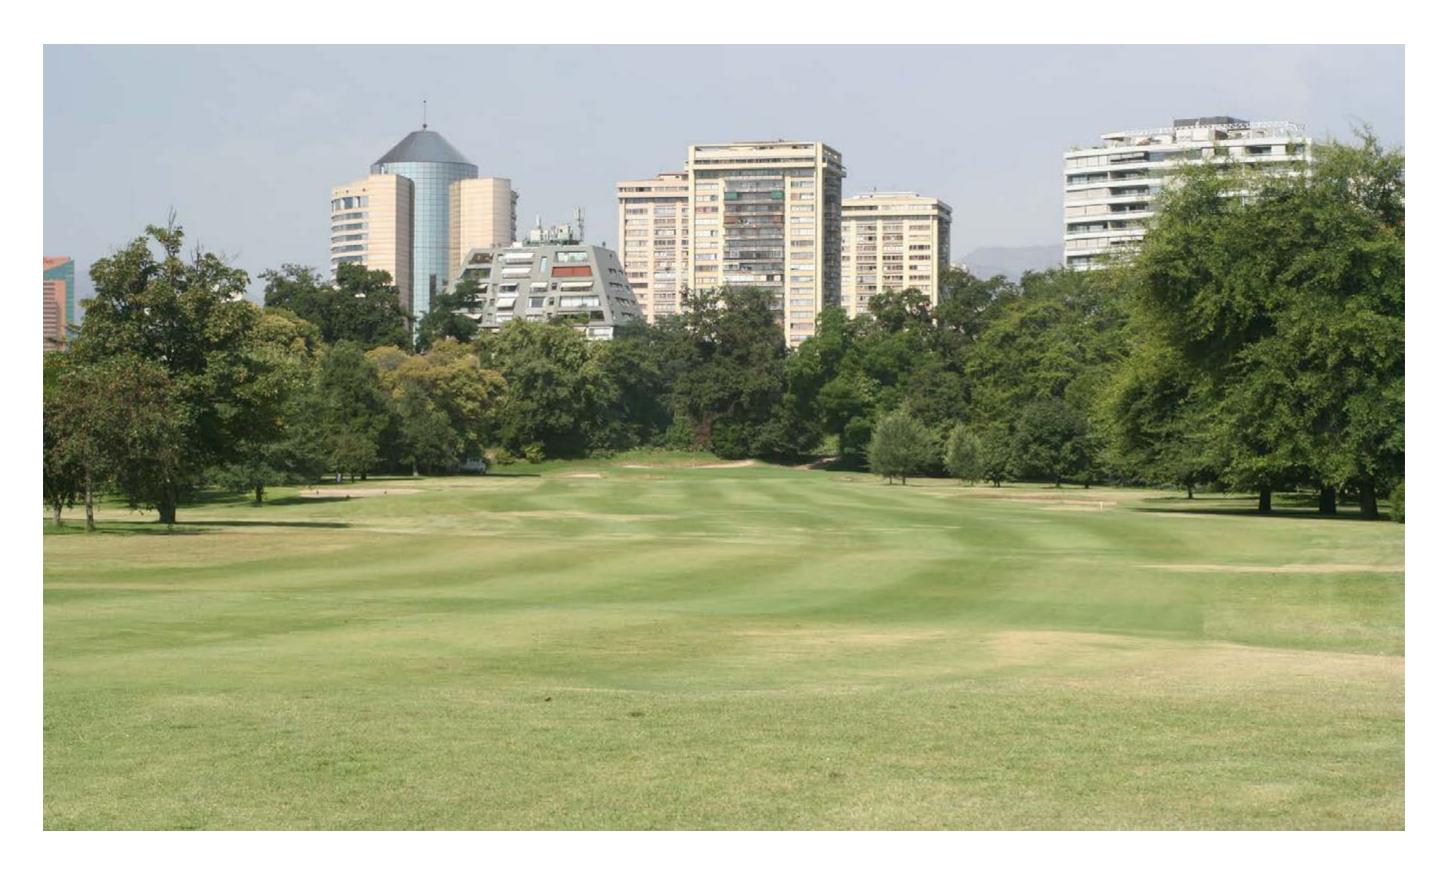
EXISTING VIEW OF THE LANDING AREA - HOLE N°5

At present the fairway bunkers are not visible even though they are in play for the vast majority of players.

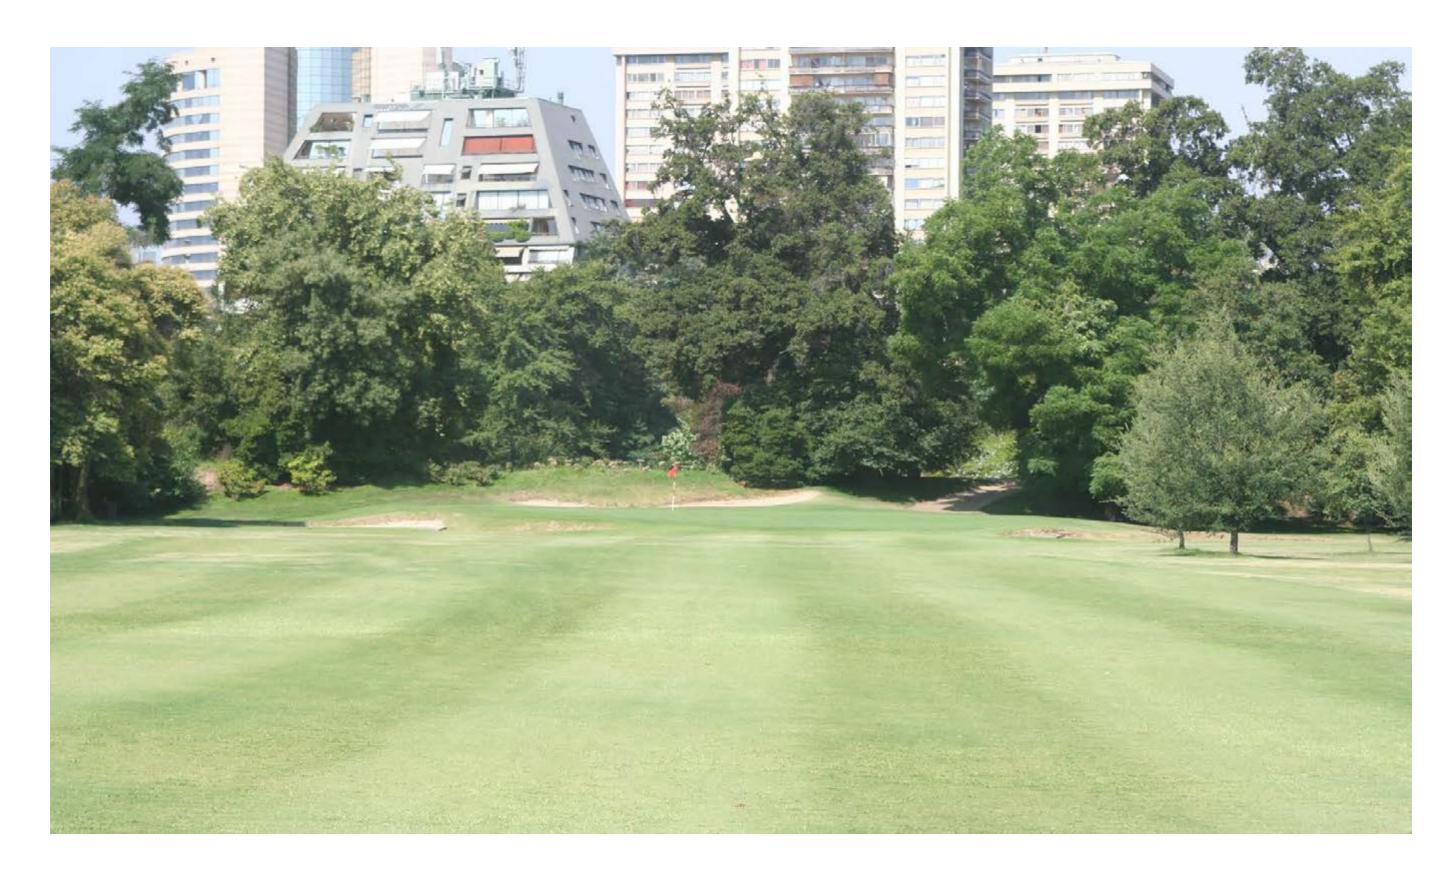
EXISTING VIEW OF THE GREEN AREA - HOLE N°5

At present the left green bunker and the right green bunker need to be made more visible. The back green bunker lacks definition.

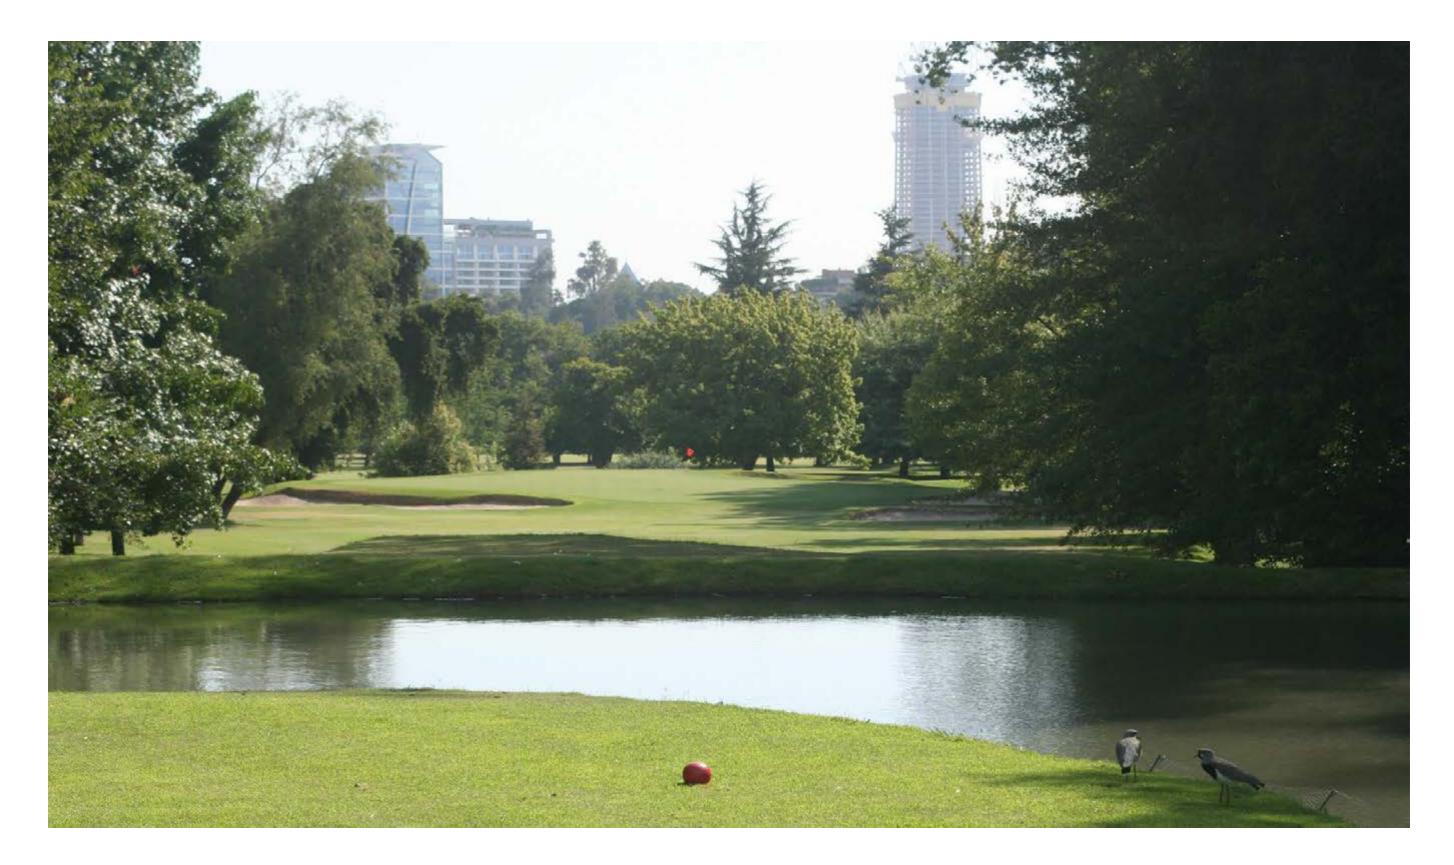
EXISTING VIEW FROM THE TEE - HOLE N°6

At present the tree branches on the right side just after the lake are partially blocking the view of the two right side bunkers. The back green bunker is barely visible. The lip of the left green bunker needs to be softened for a better visual appearance and to facilitate maintenance.

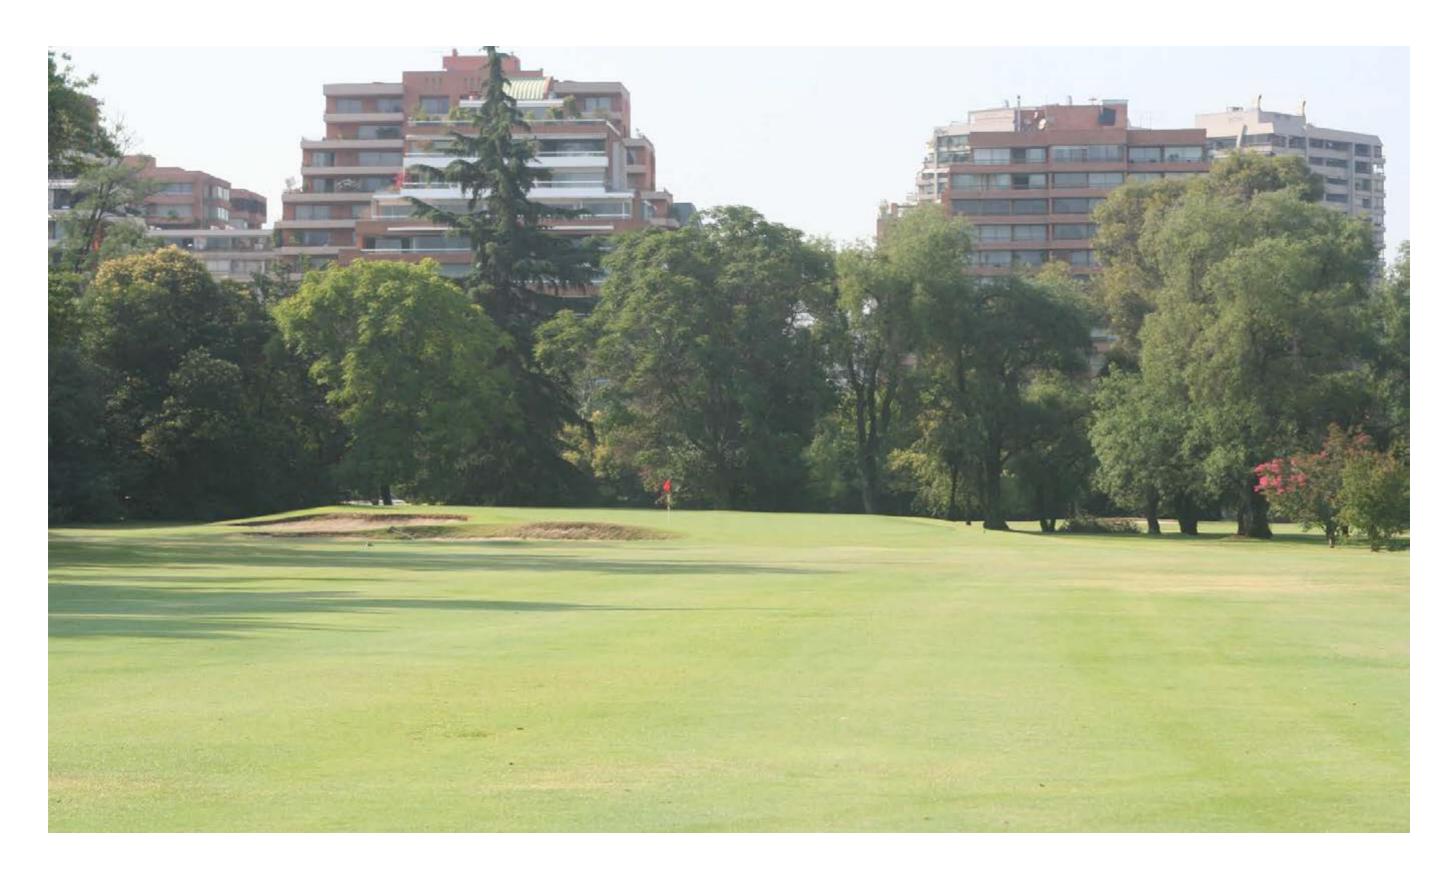
EXISTING VIEW OF THE GREEN AREA - HOLE N°7

At present the bank of the front green bunker needs to be softened. The right side of the green is totally open.

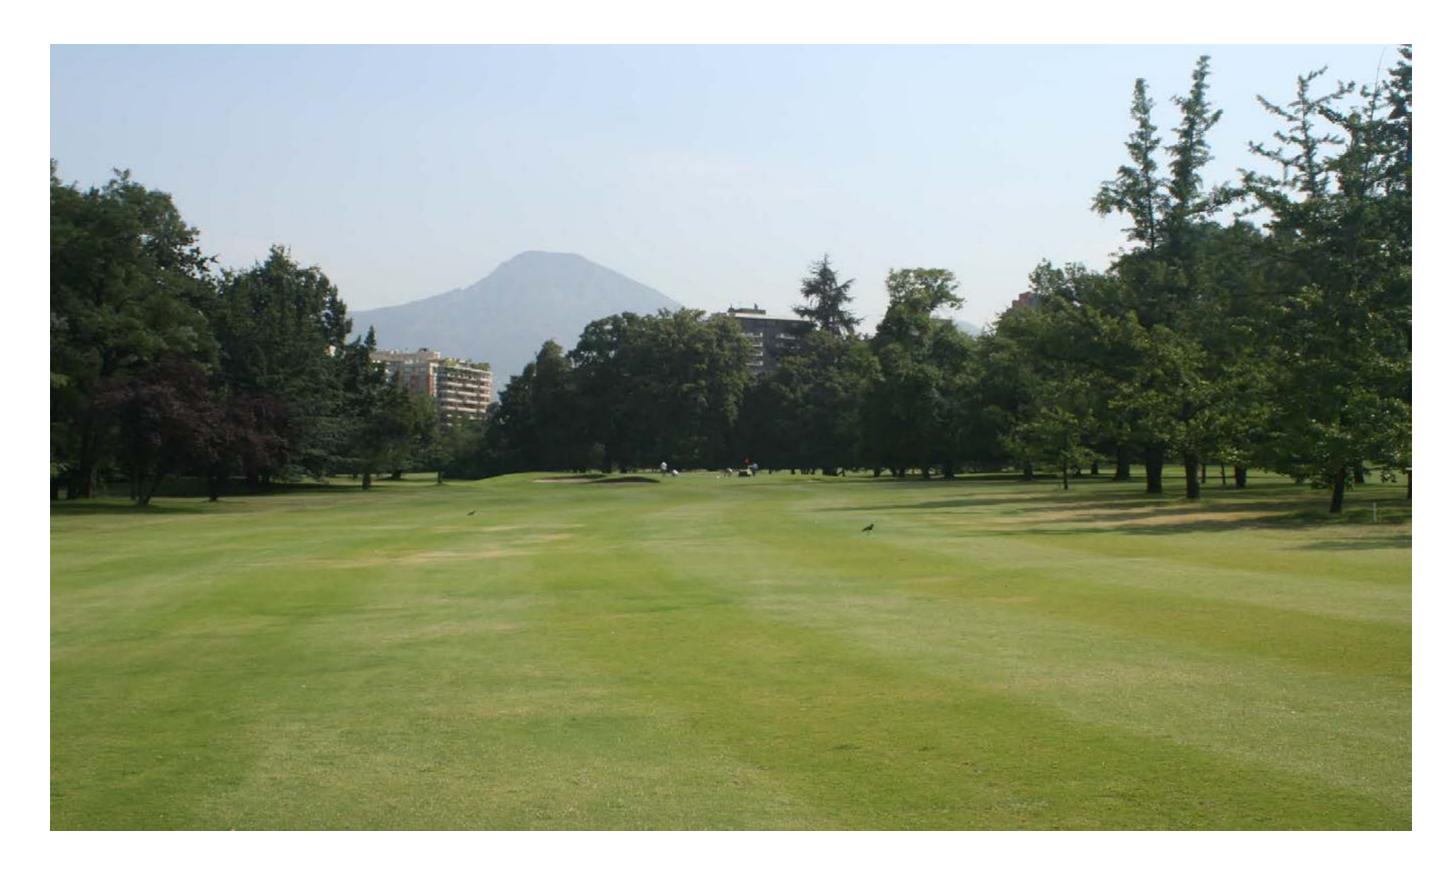
EXISTING VIEW FROM THE LANDING AREA - HOLE N°8

At present the back green bunker is not very visible and as such loses its strategic value. The right green bunker needs to be made much more visible.

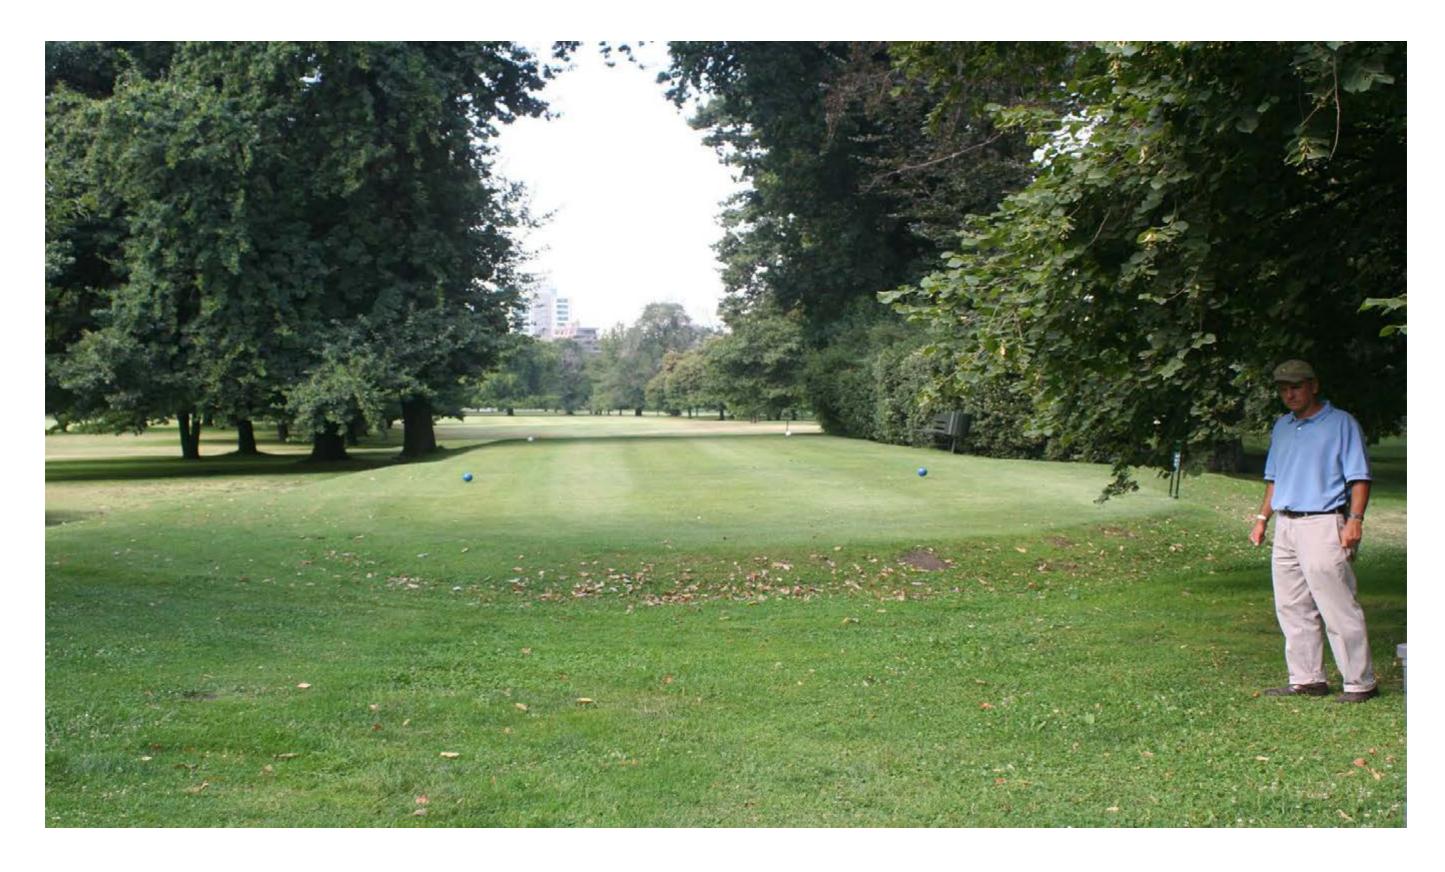
EXISTING VIEW FROM BEHIND THE BACK TEE - HOLE N°9

At present from the back tee, some players are cutting the dog-leg, especially during the Copa de Andes tournament.

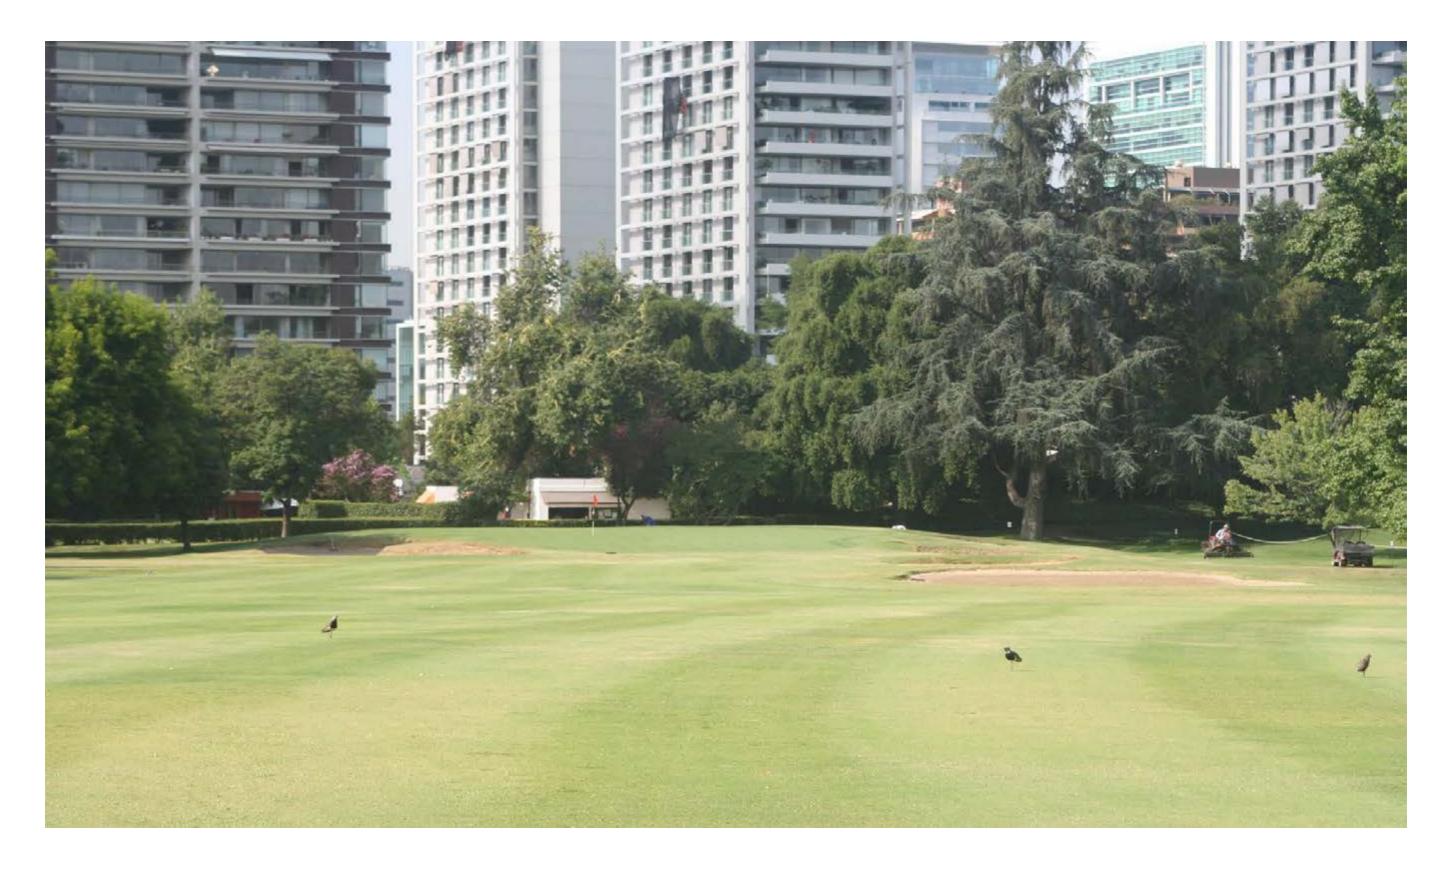
EXISTING VIEW FROM THE SECOND LANDING AREA - HOLE N°9

At present the left green bunker is lateral to the green and as such doesn't allow for a more difficult pin position. All the existing green and fairway bunkers need remodelling. The second green bunker on the right needs to be more visible.

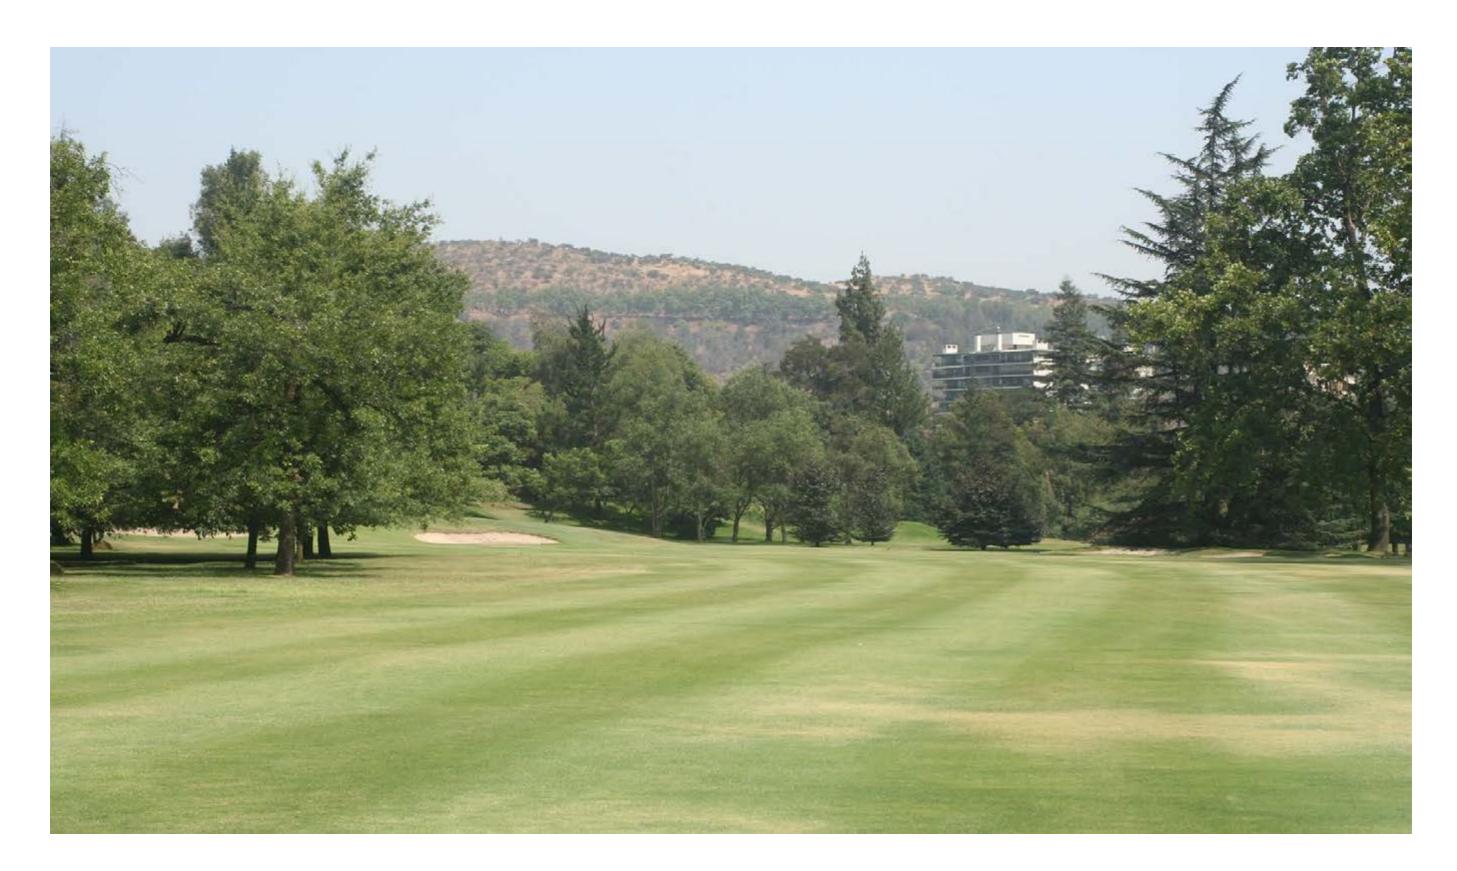
EXISTING VIEW OF THE LANDING AREA - HOLE N°10

At present this short par 4, poses no challenges and choices off the tee. The bunkers on the right could be made more visible.

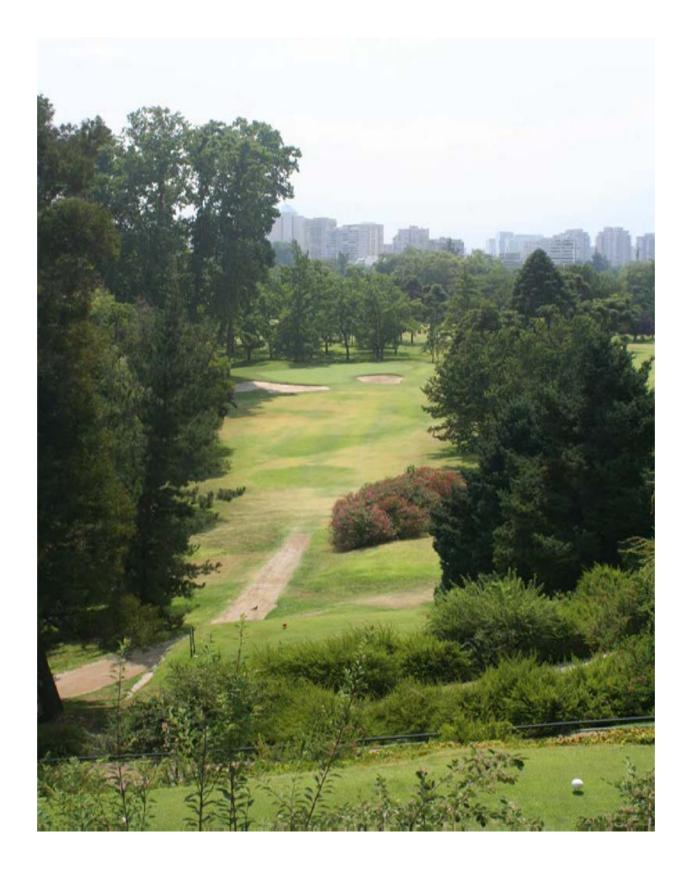
EXISTING VIEW FROM THE TEE - HOLE N°11

At present the cart path is spoiling this very picturesque hole. The pine tree on the left is blocking the view of the left side of the green bunkers from the tee.

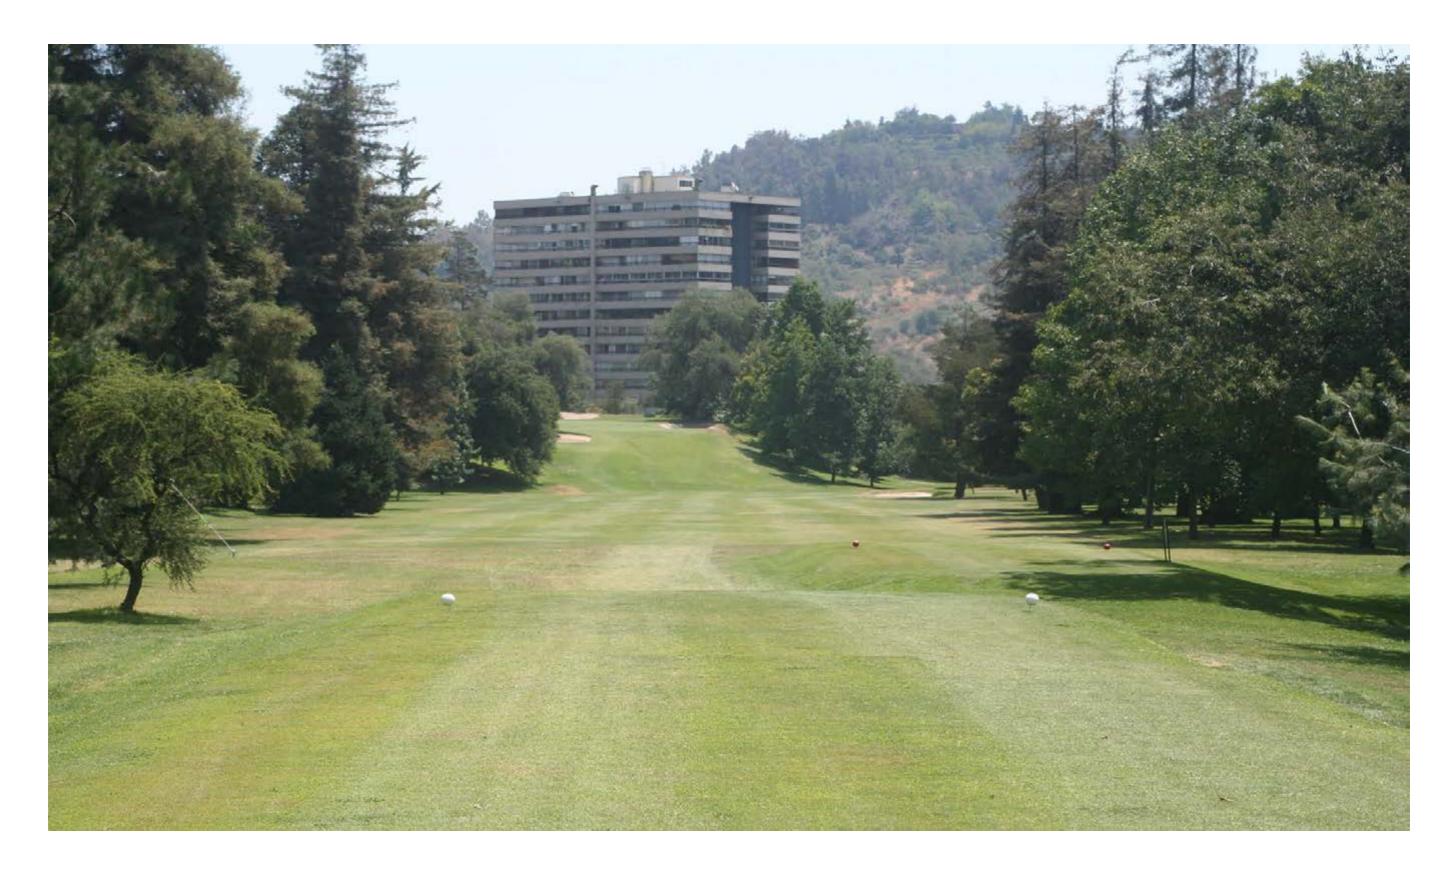
EXISTING VIEW FROM THE TEE - HOLE N°12

At present the path on the right side of the tee needs to be remodelled. The tree just before the green on the left side is blocking the view of the left side of the green and part of the green bunker on the left side.

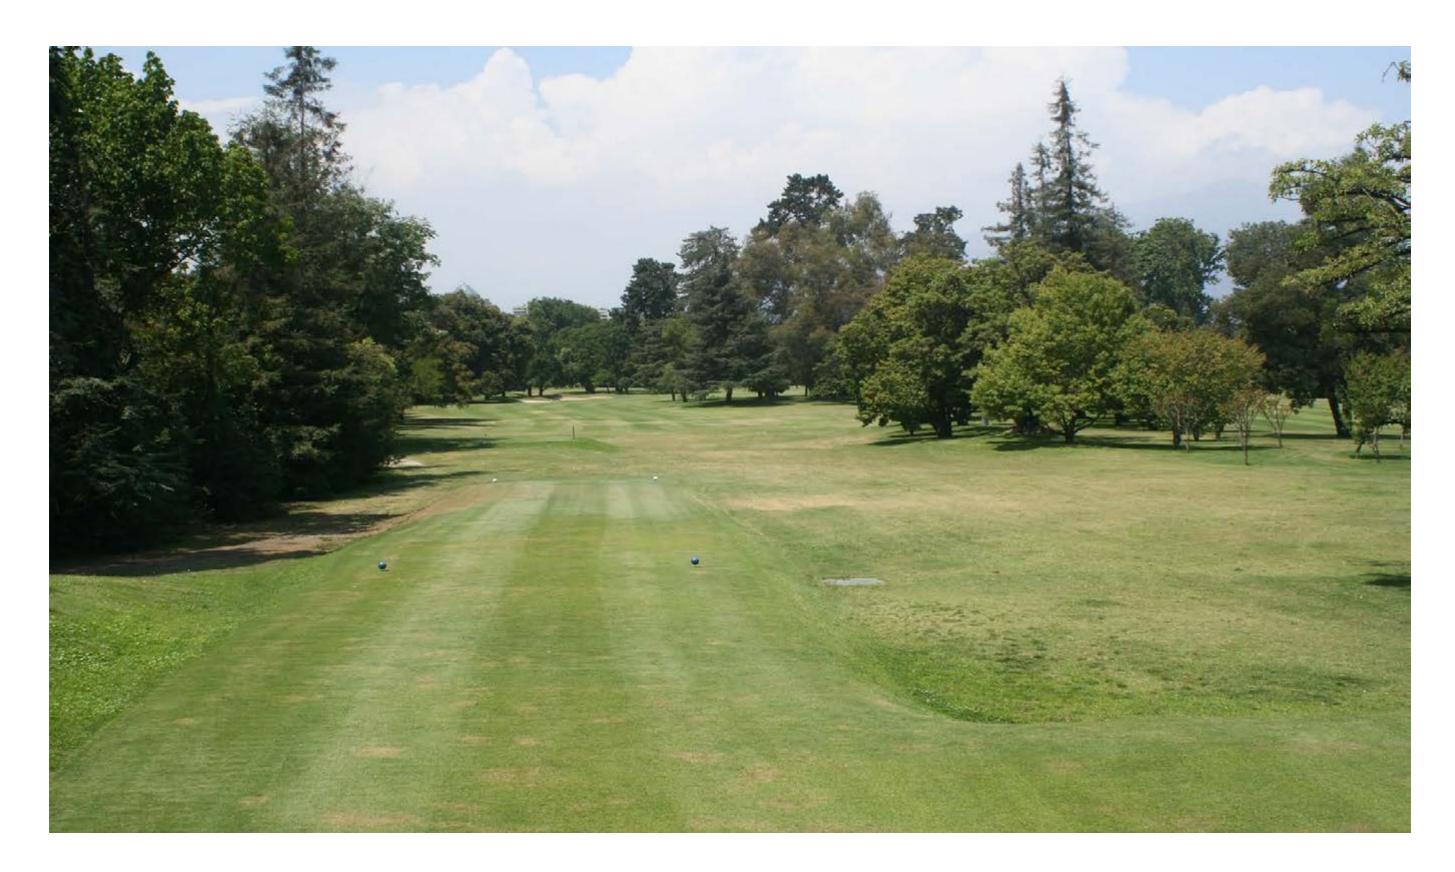
EXISTING VIEW FROM THE TEE - HOLE N°13

At present the tee box is quite narrow.
