CLUB DE GOLF LOS LEONES LAS CONDES - SANTIAGO - CHILE

SITE REPORT FOLLOWING VISIT IN JANUARY 2011

A D A M G O L F D E S I G N ARQUITECTOS DE CANCHAS DE GOLF

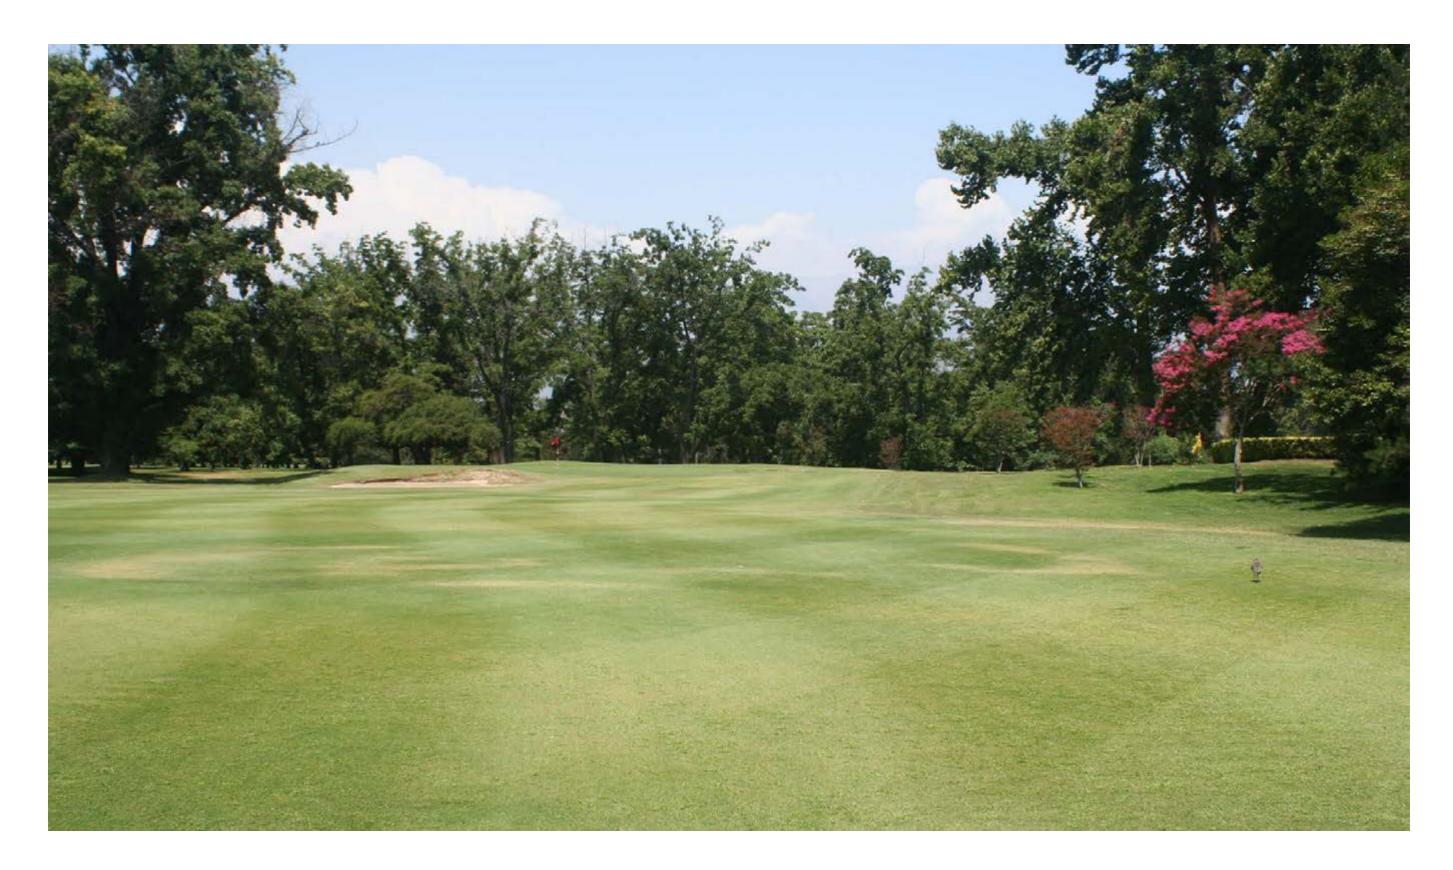
EXISTING VIEW OF THE GREEN AREA - HOLE N°13

At present the bank of the left green bunker needs to be softened and the sand line raised for a better composition of the green. The right side bunker is nearly invisible. From this photo one can also appreciate the dangerousness of the existing path between the green of hole n°11 and the tee box of hole n°12. (see proposal for the new path)

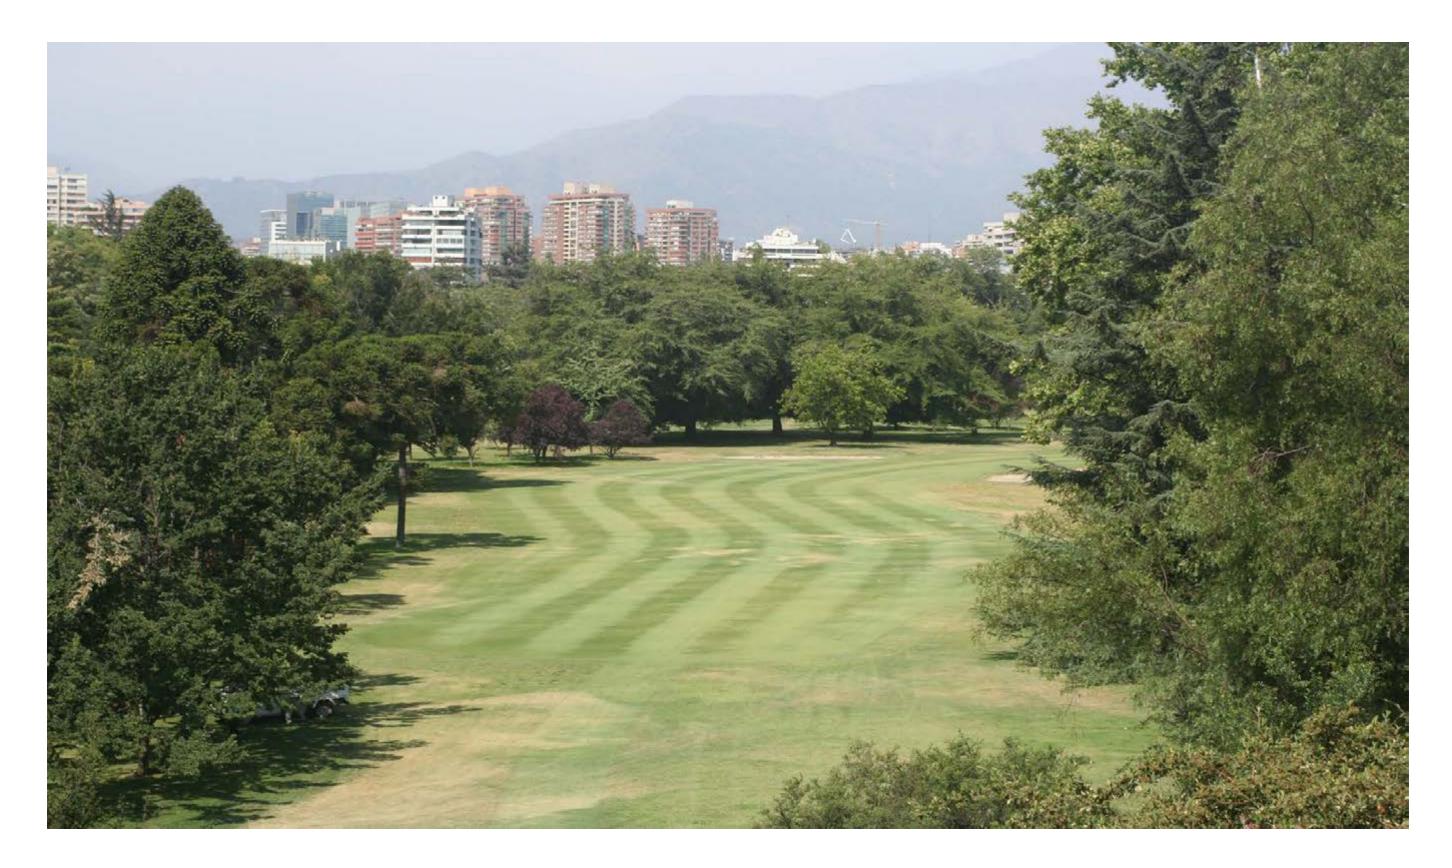
EXISTING VIEW FROM THE TEE - HOLE N°15

At present from the tee one cannot see the 2nd fairway bunker on the right. The left fairway bunker is visually a straight line and not very visible. From the beginning of the fairway, no fairway bunkers are visible.

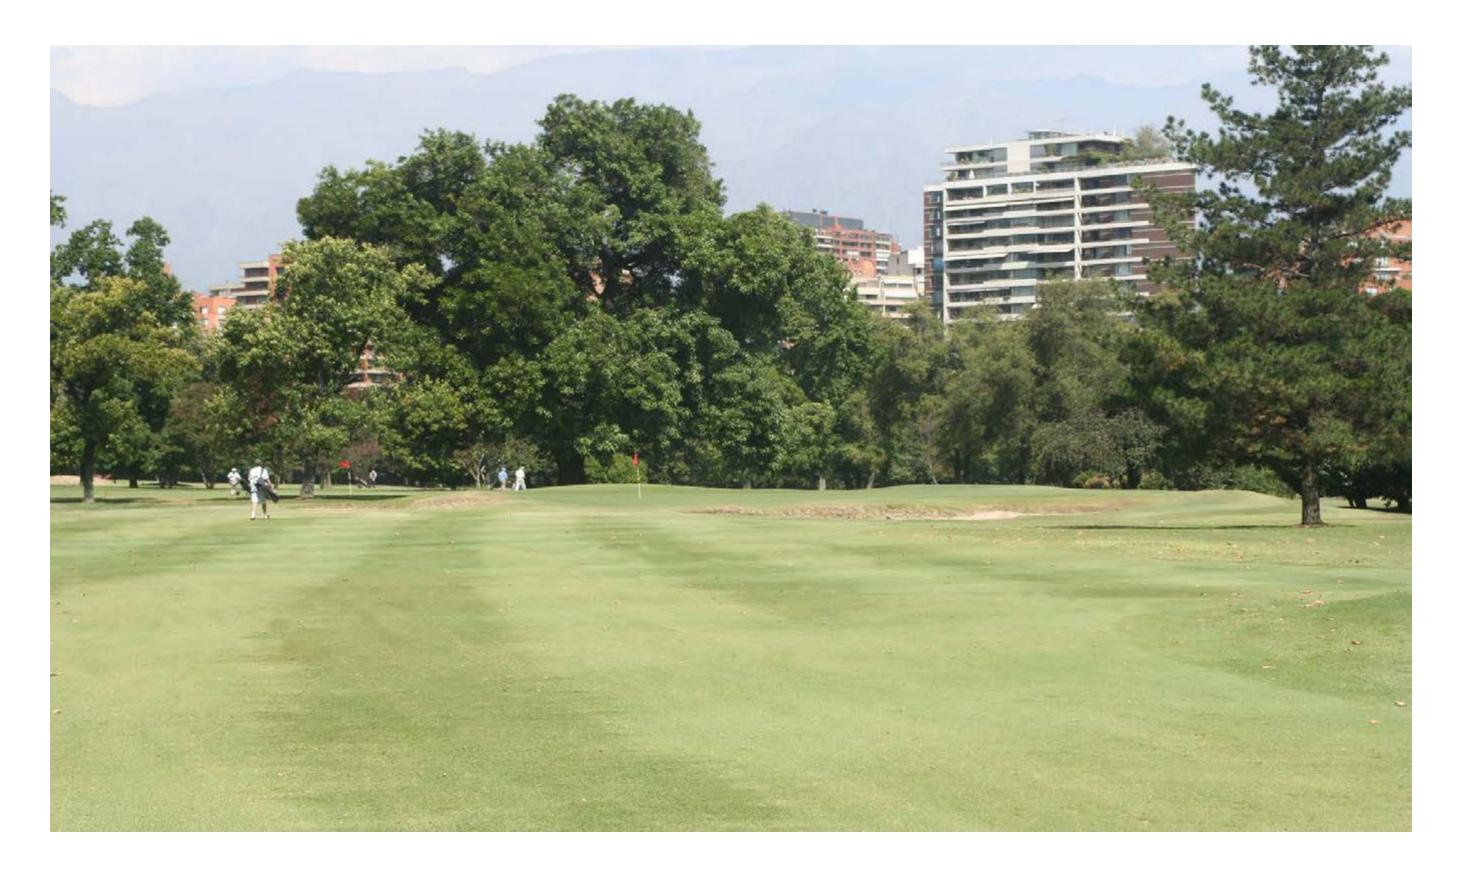
EXISTING VIEW OF THE GREEN AREA - HOLE N°15

At present the left and right green bunkers are not really visible. The banks of the bunkers also need to be softened to facilitate maintenance.

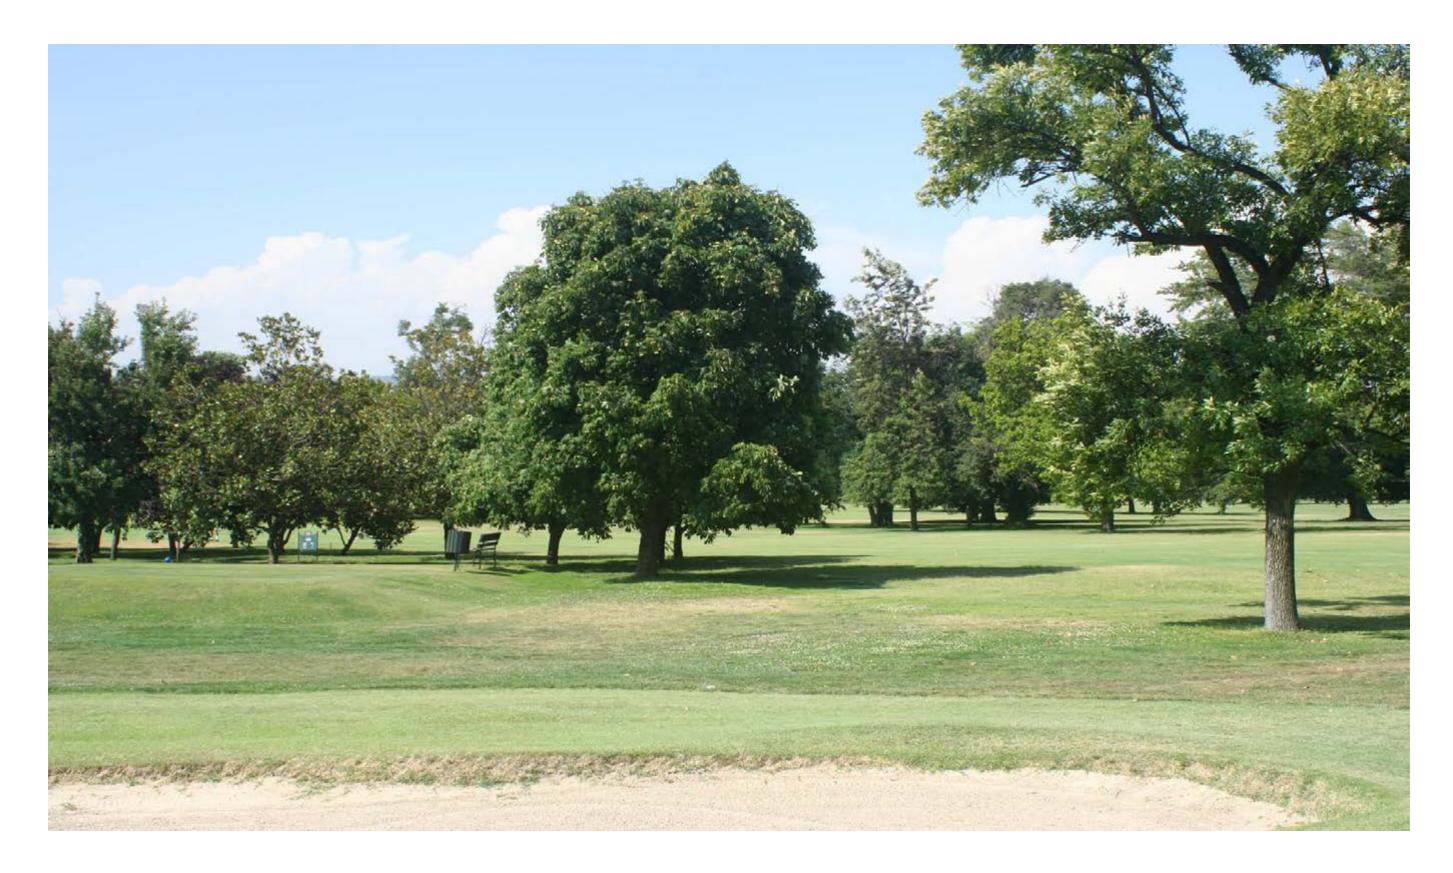
EXISTING VIEW OF THE TEE FROM GREEN N°15 - HOLE N°16

At present some players are hitting over the trees at the dog-leg. The tees themselves are disconnected making their maintenance harder.

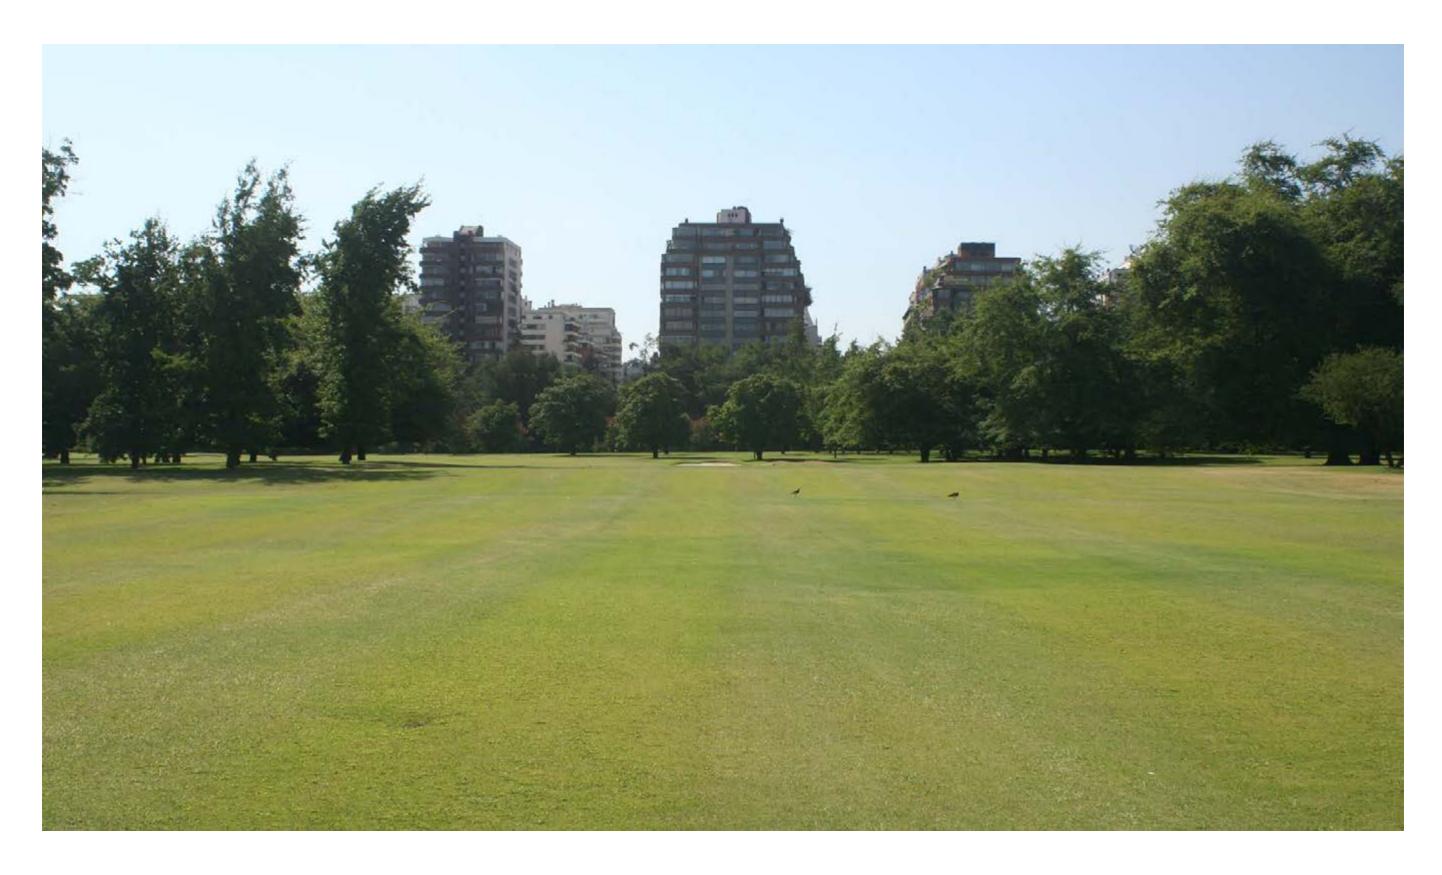
EXISTING VIEW OF THE LANDING AREA - HOLE N°16

At present the cross fairway bunkers are hardly visible.

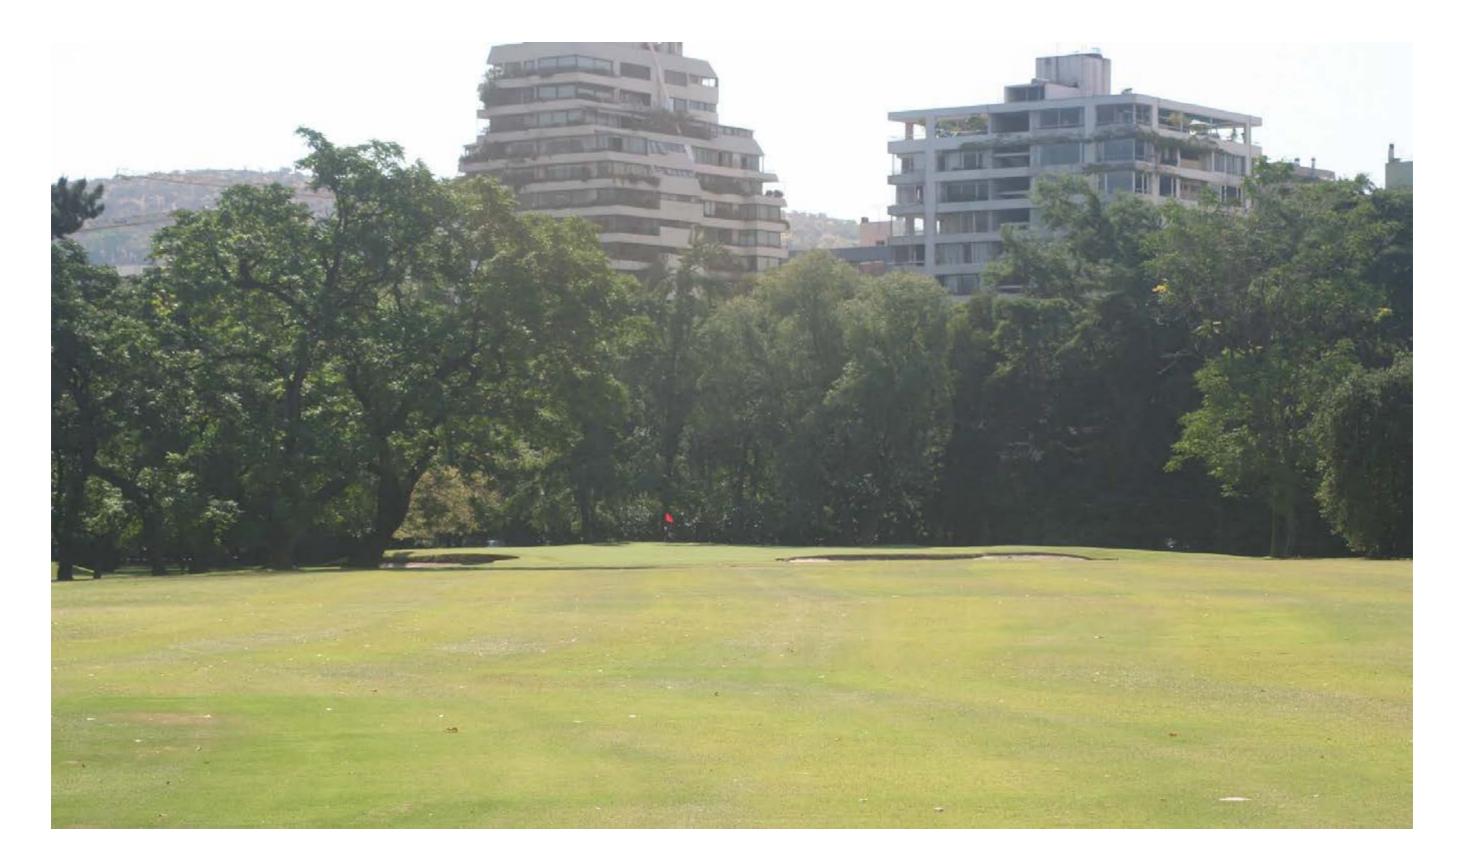
EXISTING VIEW OF THE GREEN AREA - HOLE N°16

At present the right green bunker is visually a flat line. The left green bunker is difficult to see due to the shade of the tree.

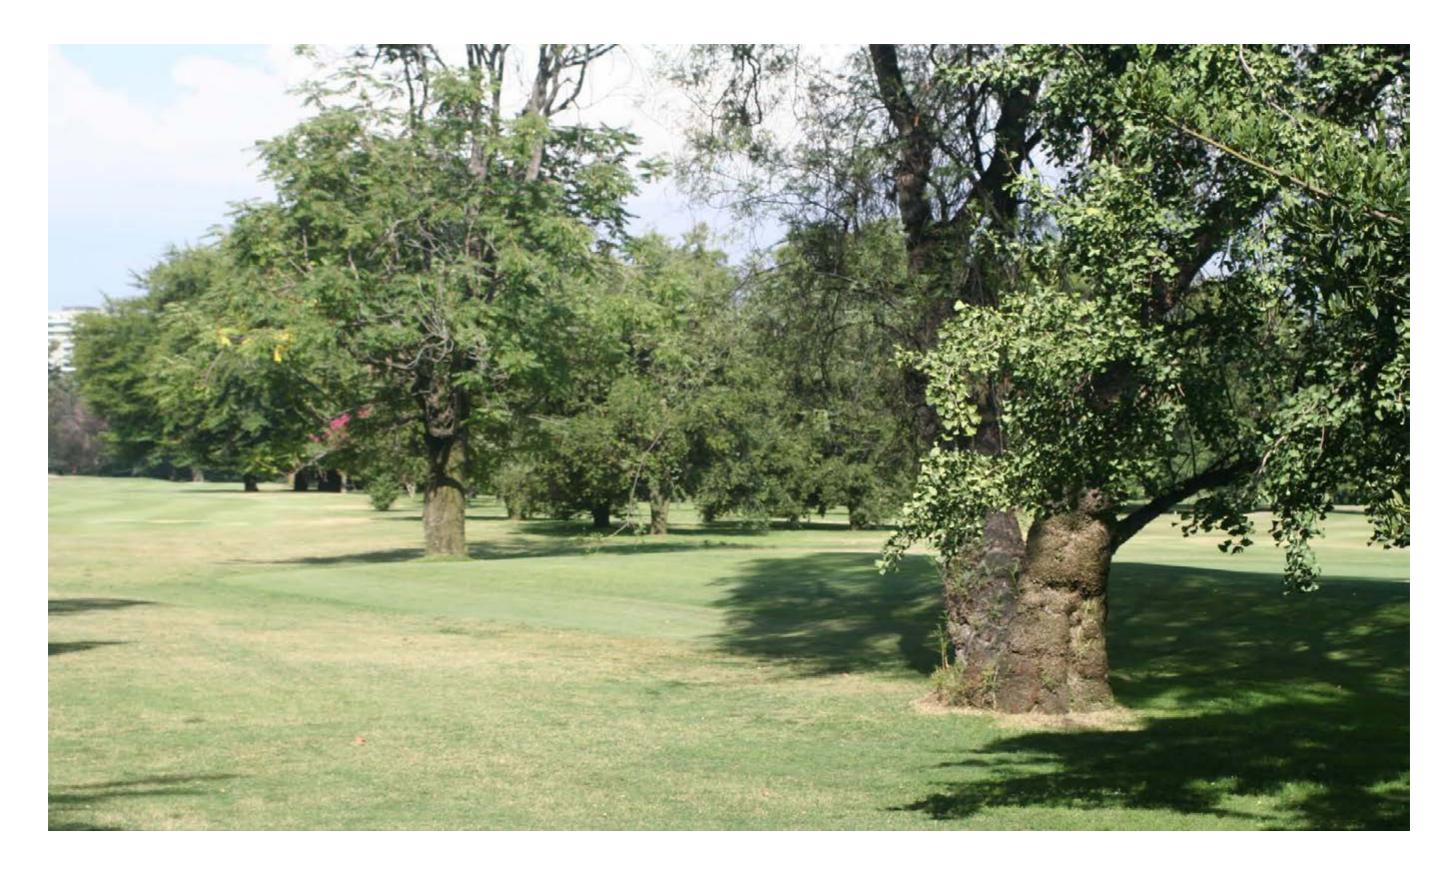
EXISTING VIEW OF THE GREEN AREA FROM TEE N°17 - HOLE N°16

At present someone playing off the tee on hole n°17, can easily shank the ball right, across the edge of the green n°16 and over the right green bunker. We believe this situation to be particularly dangerous, as the ball off the tee will be travelling at full velocity.

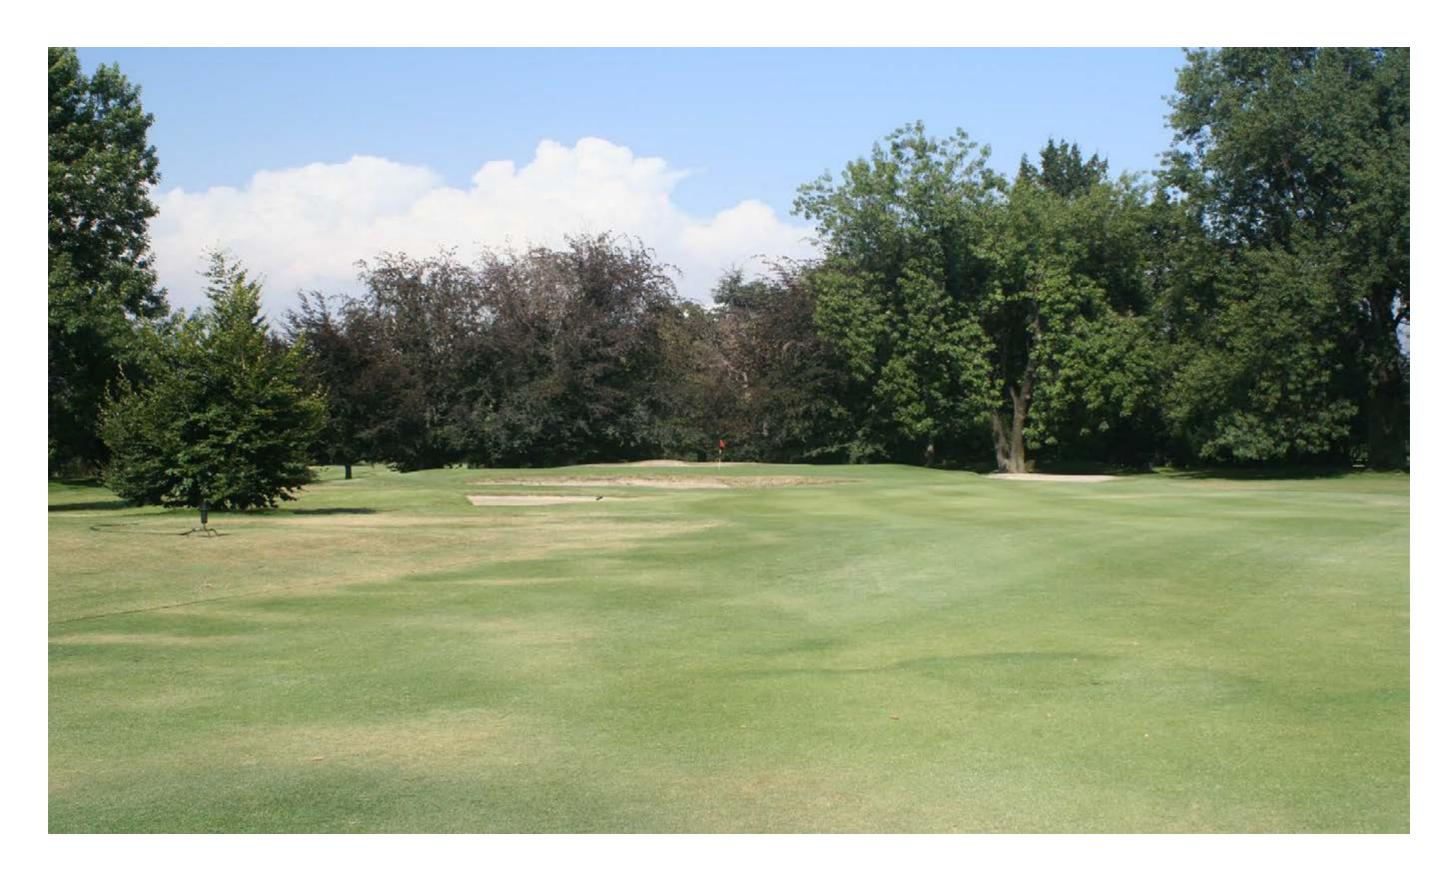
EXISTING VIEW OF THE GREEN FROM THE 2ND LANDING AREA - HOLE N°17

At present the fairway bunker on the right side of the 2nd landing area is completely flat and invisible. As I understand it, this bunker was placed to complicate the landing area for those in the trees on the right side of the 1st landing area. It's intent is to complicate the recovery shot. The front green bunker is not very visible. The right green bunker is visible but it appears as a horizontal line on the horizon. The back green bunker could be made more visible.

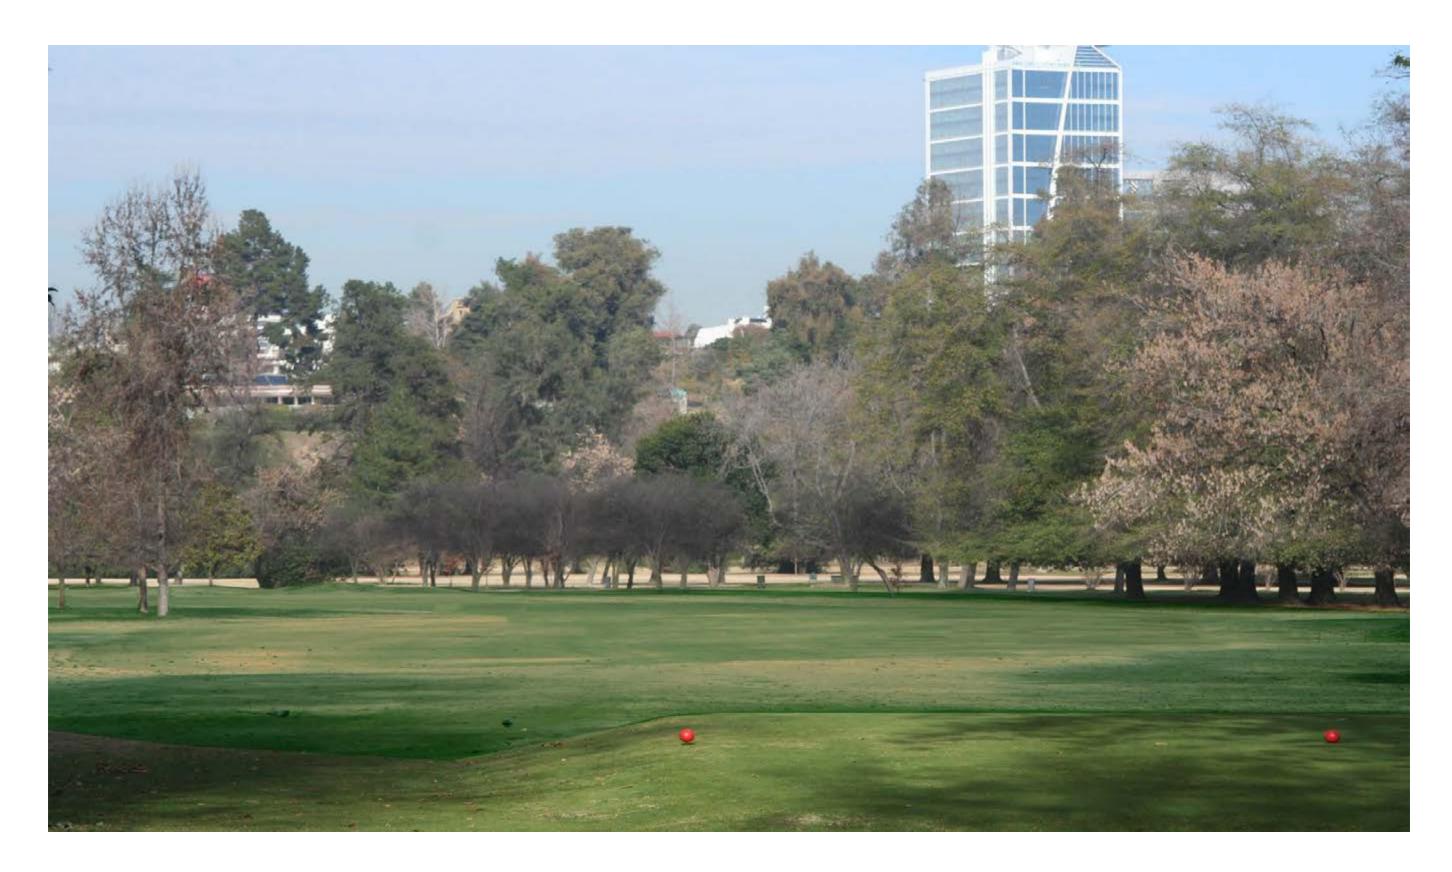
EXISTING VIEW FROM THE TEE - HOLE N°18

At present from the tee the fairway bunkers are barely visible.

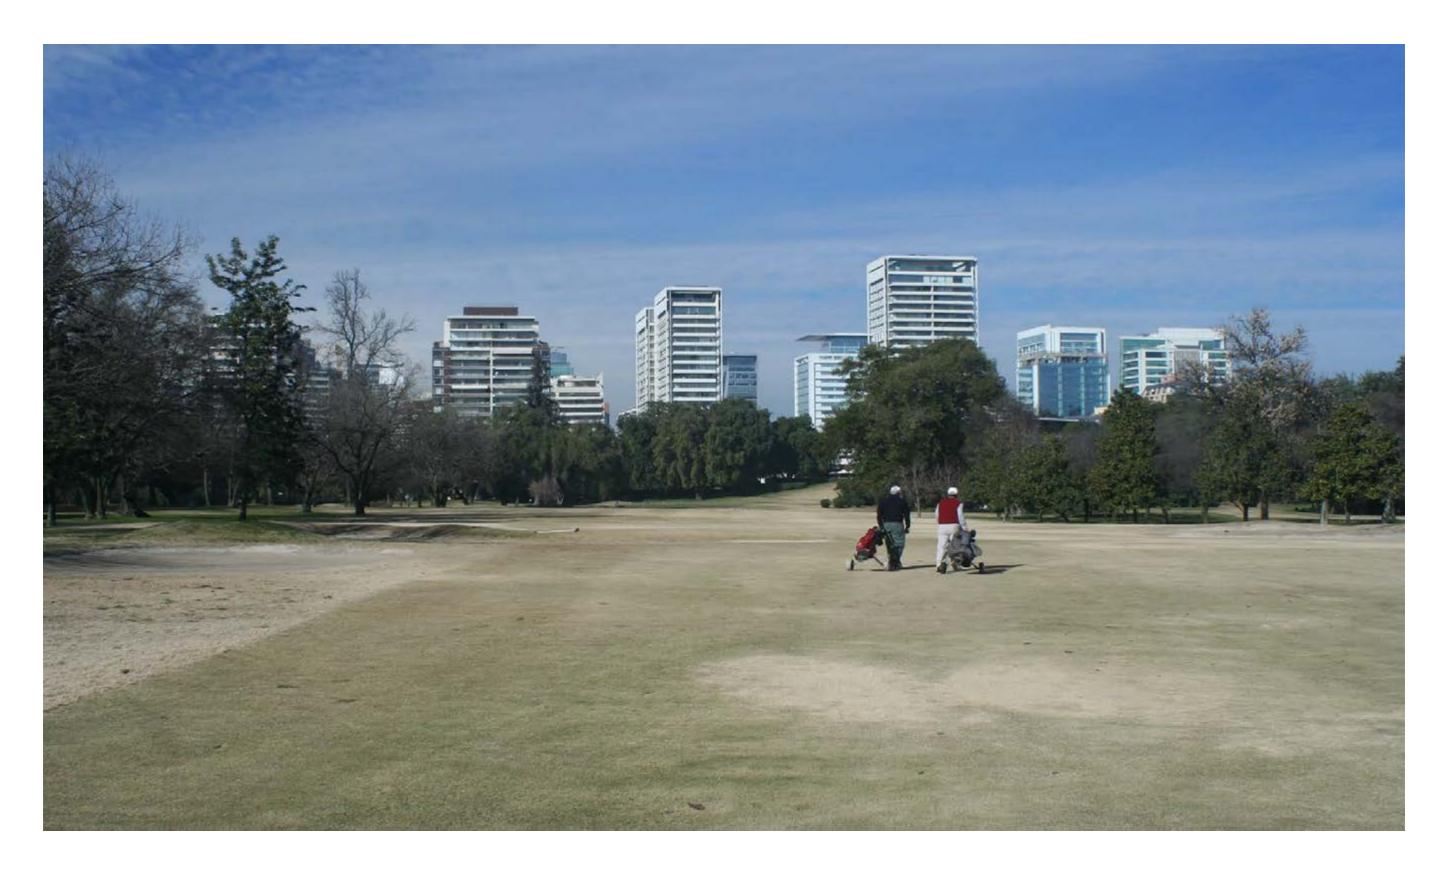
EXISTING VIEW FROM THE 1st LANDING AREA - HOLE N°18

At present the fairway bunkers are not really visible and loose in their strategic and aesthetic value.
